GROUP	MODEL
GEN	2023-2024MY Forte (BDm)
NUMBER	DATE
099	February 2024

TECHNICAL SERVICE BULLETIN

SERVICE ACTION: TIRE MOBILITY KIT INSPECTION & REPLACEMENT/REPAIR (SA556)

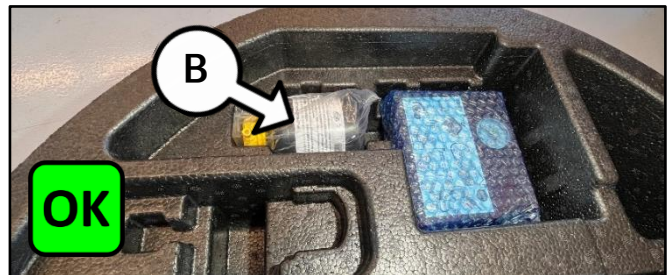
- If sealant has not leaked from the TMK can (B) (OK), proceed to step 4.

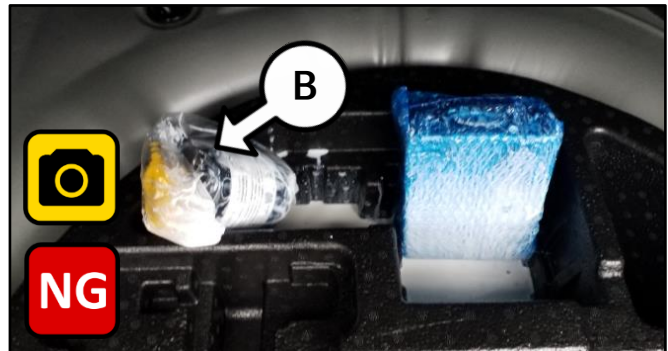
- If sealant has leaked from the TMK sealant can (NG), replace the sealant can (B), take one (1) clear KVID photo and proceed to 'Repair Procedure' step 5.

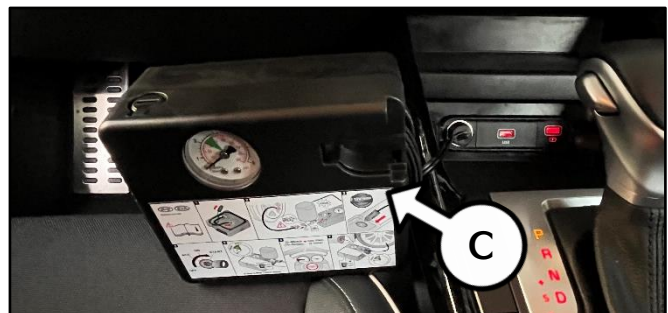
If leaked sealant has penetrated the inflator bag, test the inflator (C) for proper operation. If inflator and/or other damaged parts require replacement due to leaked sealant, follow normal warranty procedures and attach a KVID photo of the damaged component to the warranty claim.

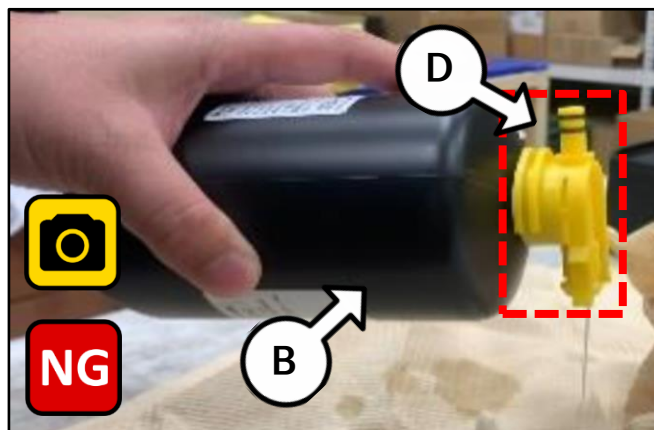
- If sealant has **not** leaked from the sealant can cap (D) (**OK**), proceed to the 'Repair Procedure'.
- If sealant has leaked from the sealant can cap (D) (**NG**), replace the sealant can (B), **take one (1) clear KVID photo** and proceed to 'Repair Procedure' step 5.

4. Remove sealant can (B) from the bag and position horizontally so the spout is facing downward.
