Technical Service Bulletin

19 Coolant warning light on OR Coolant pump replaced due to a coolant leak - 4.0 TFSI

19 24 52 2065040/4 February 19, 2024. Supersedes Technical Service Bulletin Group 19 number 24-48 dated January 30, 2024 for reasons listed below.

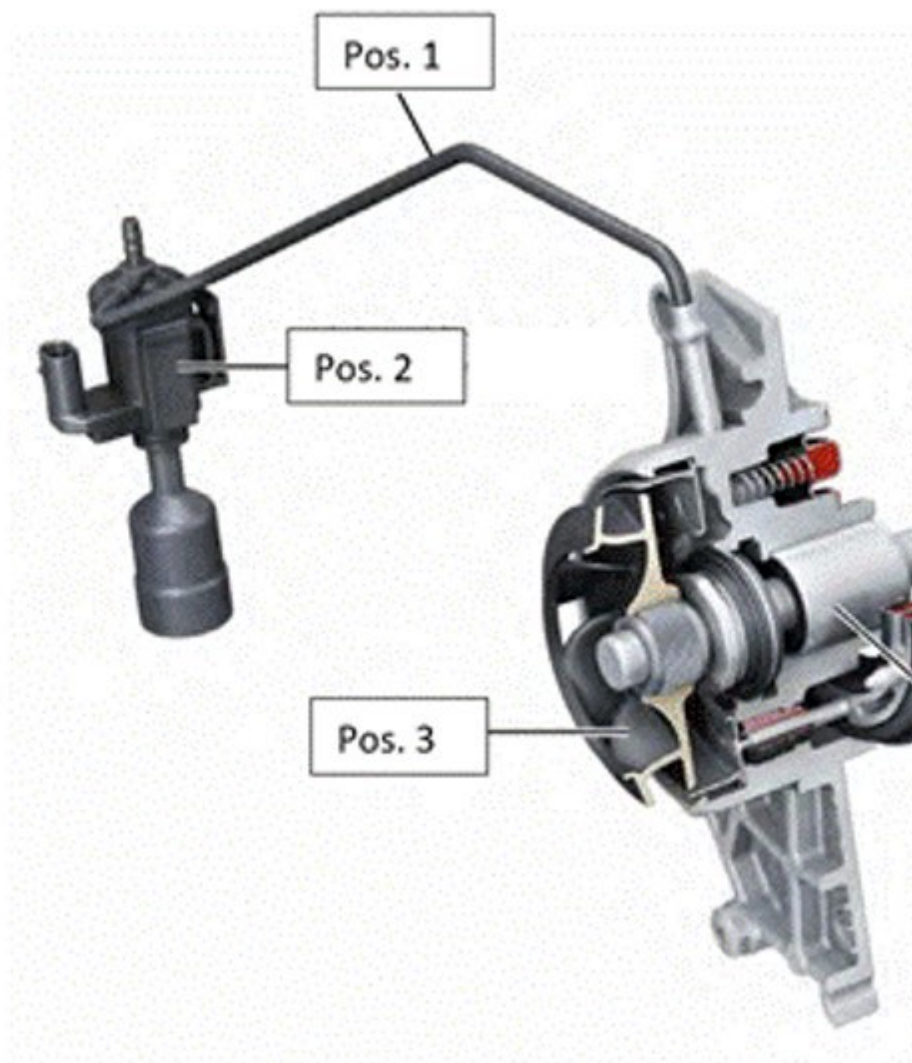
Figure 1. Mechanical coolant pump.

- The coolant pump is identified as cause of coolant leak.

- Position 1 – control line.
- Position 2 – switch valve for mechanical coolant pump N649.
- Position 3 – mechanical coolant pump.

When performing work on the cooling system which requires the mechanical coolant pump to be replaced, it must be ensured that there is no coolant residue or fluid in the control line (Figure 1, position 1.) If there is, switch valve N649 must also be replaced in addition to the coolant pump and the control line must be cleaned/dried.

If coolant can be detected beyond the N649 switch valve, replace any components connected to the vacuum system that show signs of coolant ingress.
