# Technical Service Bulletin

## 20 Noises from the fuel line

20 24 66 2059997/5 February 19, 2024. Supersedes Technical Service Bulletin Group 20 number 23-53 dated January 31, 2023 for reasons listed below.

Model(s)	Year	VIN Range	Vehicle-Specific Equipment
Q3	2019 - 2024	All	Not Applicable

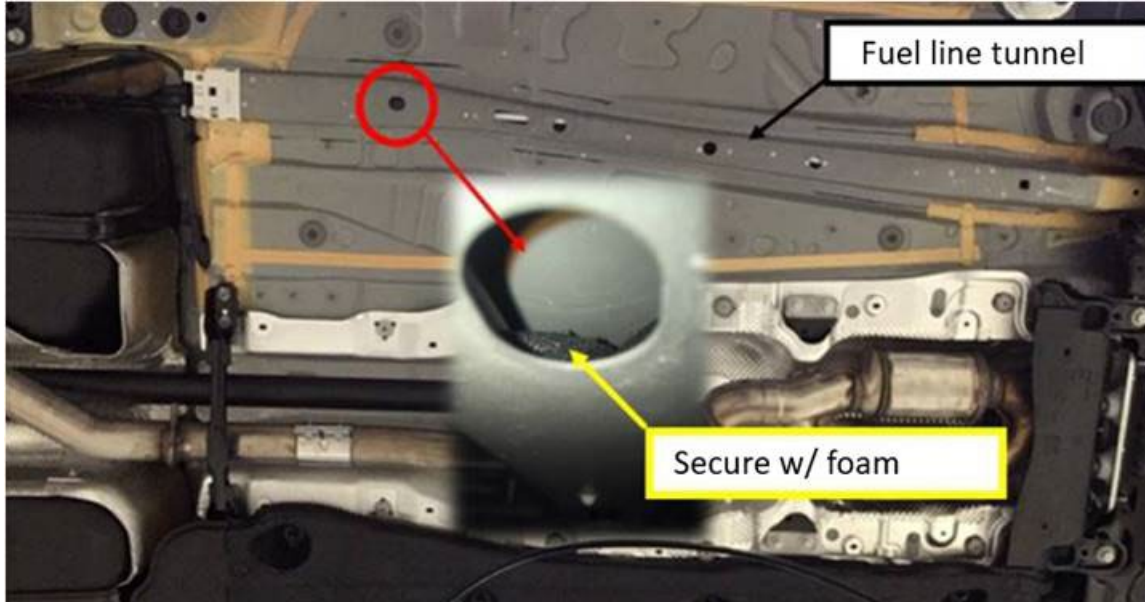
- The fuel/EVAP lines in the longitudinal member start to vibrate in certain operating situations and this creates the noise.

Due to pressure pulsation from the high-pressure pump on engine side the underfloor line in the underbody tunnel vibrates. This vibration causes noise that can also be heard in the vehicle interior.

**Figure 1.** Location of the vibrating fuel line.

2. Install closed-cell foam (foam that doesn't soak up water) part number 321 201 299 on the fuel and EVAP line tunnel or fill the space around the fuel and EVAP lines. The fuel/EVAP line does not have to be removed. If this does not work, then install a toothed lock washer 06A 141 730 A.

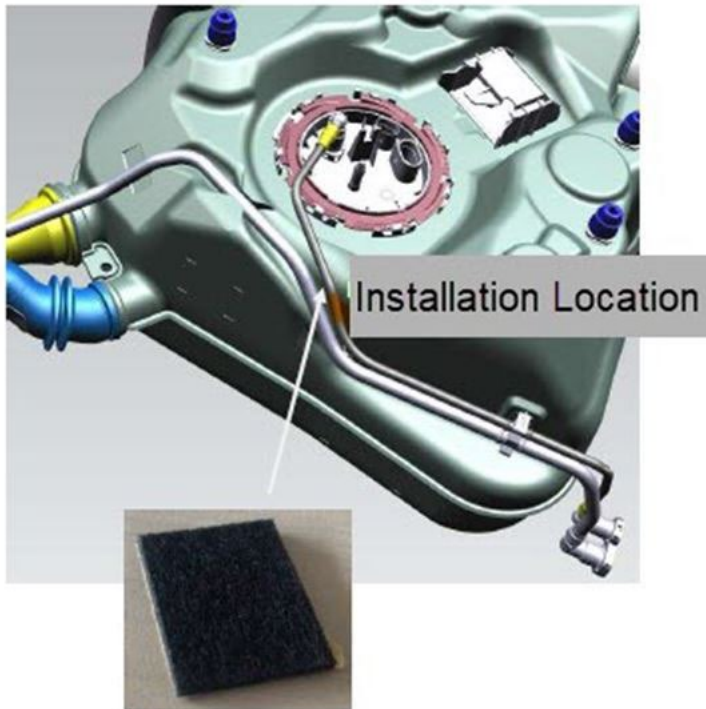
**Figure 2.** Felt installation location, between tank and fuel line.

3. Reinstall the underbody cover.
4. Please use a felt piece 4B0 857 579. Attach it to the fuel tank as shown in the image below (Figure 2).
