Technical Service Bulletin

40 Creaking noises from front of the vehicle when driving - Q7, Q8, A8, e-tron

40 24 74 2058489/8 February 15, 2024. Supersedes Technical Service Bulletin Group 40 number 24-70 dated January 12, 2024 for reasons listed below.

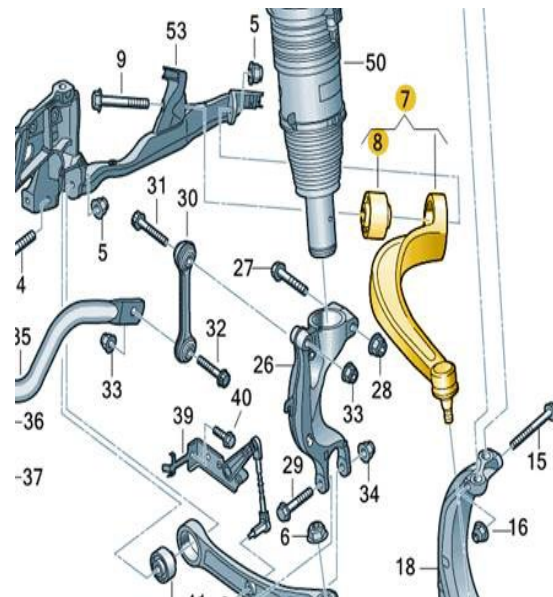
Figure 1. Hydro-bush.

The noises can be generated on the lower-left guide in the area of the hydro-bushing. (Figure 1, Positions 7 and 8).

The noises from the guide link can be transmitted into the vehicle interior by the connection of the subframe on the body and are noticeable in the footwell.

1. Replace the hydro-bushing on the guide link in pairs (Figure 1, Position 8) according to the instructions in the ELSA Repair Manual at *Chassis >> Suspension >> Wheels, Steering >> 40 Front Axles >> Lower Control Arm and Ball Joint >> Guide link bonder rubber bushing, Removing and Installing.*
2. If repeat repairs are necessary and the hydro-bushing has already been replaced (pressed out/in), the complete guide link must be replaced (Figure 1, Position 7). Refer to the instructions in the ELSA Repair Manual at *Chassis >> Suspension >> Wheels, Steering >> 40 Front Axles >> Lower Control Arm and Ball Joint >> Guide link, Removing and Installing.*

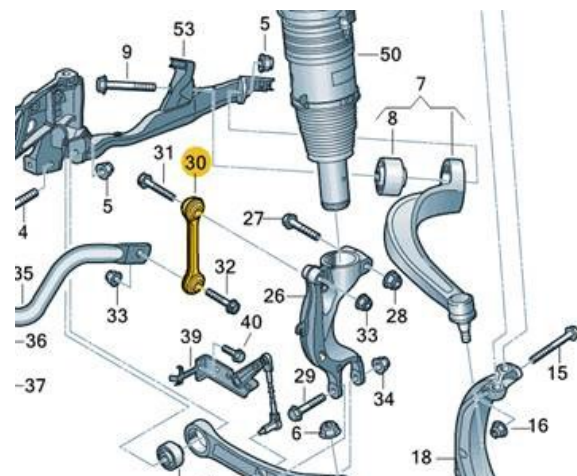
Figure 2. Coupling rod.

Parts such as the coupling rod (Figure 2, Position 30) are usually replaced by mistake, presenting no problems.
