# Service Bulletin

Bulletin No.: 18-NA-020  
Date: February, 2024

**Subject:** Malfunction Indicator Lamp (MIL) Illuminated with DTCs P0300, P0299, P0234 and/or P2227 Set

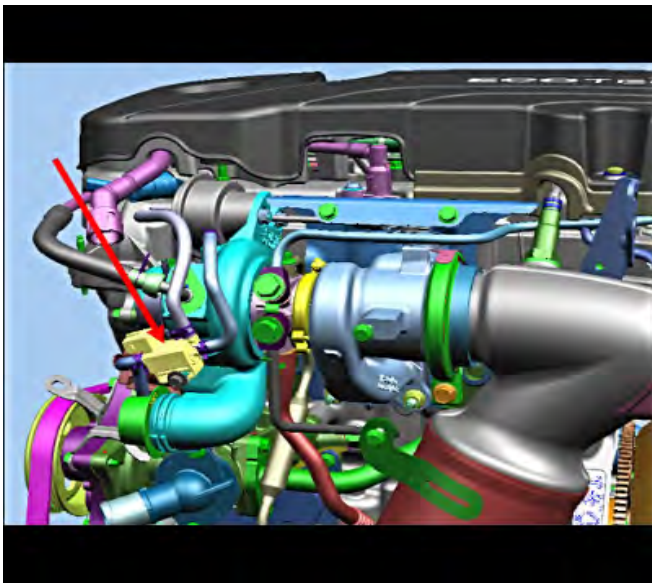
6055063

Inspect the Turbocharger Control Valve (TCV) to ensure it is not frozen.

1. Remove Turbocharger Wastegate Regulator Solenoid Valve.
2. Drain Turbocharger Wastegate Regulator Solenoid Valve (TCV) by turning valve upside down.

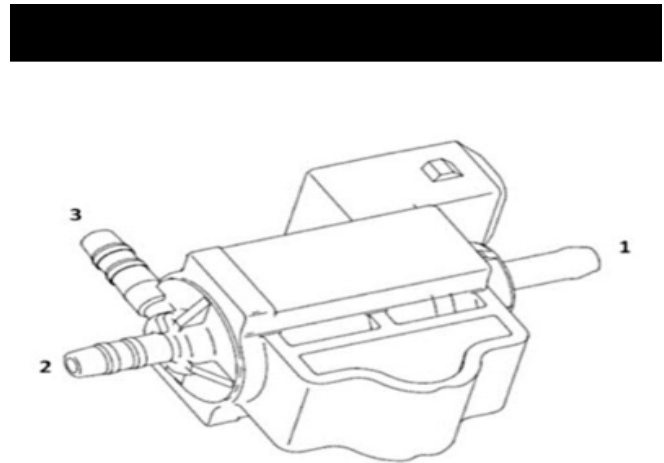
6055068

**Note:** Check port #2 to assure the spring gets lifted off the seat. This will be determined by the compressed air not dead heading when applied to port #2. When applying air to this port a small amount of air should be observed at port #3 and even less air will be noticed at port #1. If this does not happen, the TCV plunger may have hardened deposits from hot operating conditions which will impede TCV plunger movement, and the Turbocharger Wastegate Regulator Solenoid Valve should be replaced.

3. Using clean shop air regulated to 80-100 PSI (551-689 kPa), blow through all three ports (1, 2 & 3) for 5 seconds each. Repeat this step twice.

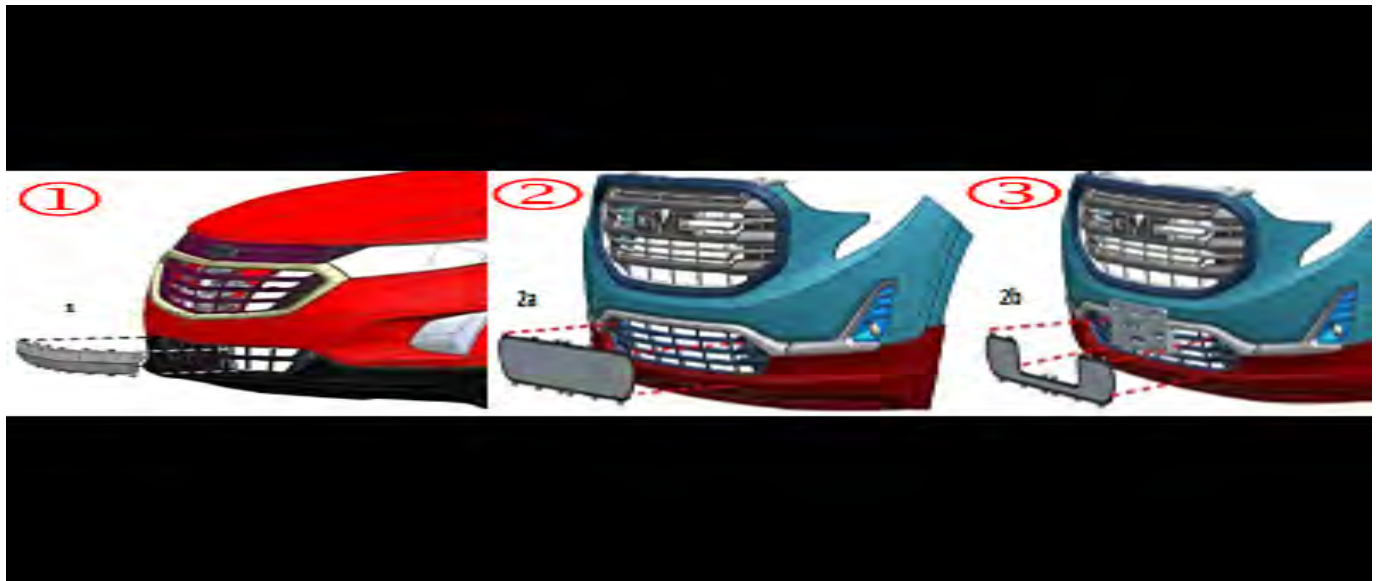
5776421

Shown in the picture above are examples of the grill opening covers for the Equinox (1), Terrain without (RPO VK3) (2) and Terrain with (RPO VK3) (3).
