Technical Service Bulletin

55 Power rear lid cannot be opened, DTC B113E07 and/or B113E29 are stored in the rear lid electronics module

55 24 90 2064020/2 February 15, 2024. Supersedes Technical Service Bulletin Group 55 number 21-58 dated July 16, 2021 for reasons listed below.

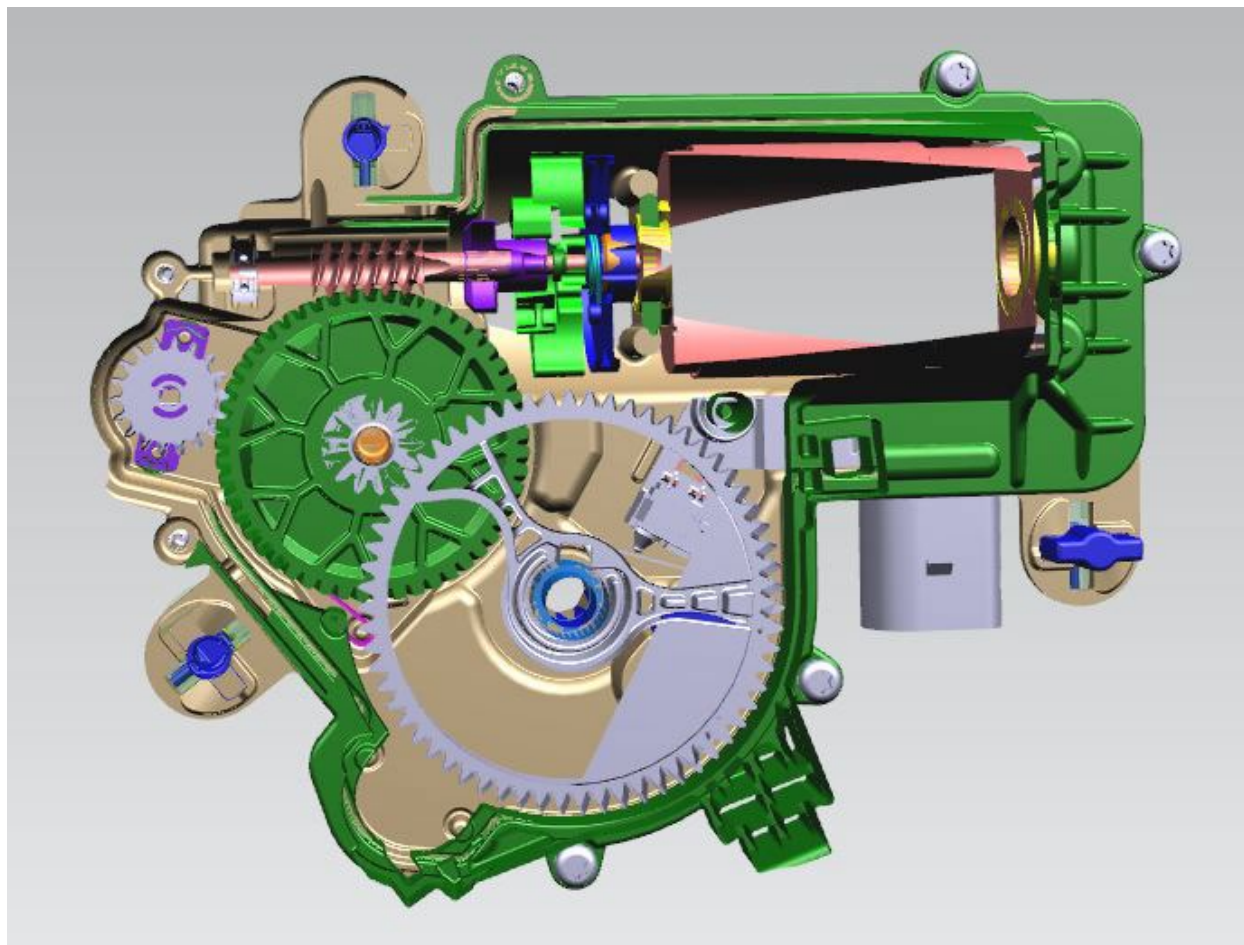
Due to component-related deviations of the rear lid closing assist motor, the closing assist motor can be internally blocked. Consequently, the power rear lid can no longer be opened as the rotary latch of the rear lid lock is not released by the closing assist motor (Figure 1).

Figure 1. Rear lid closing assist motor.

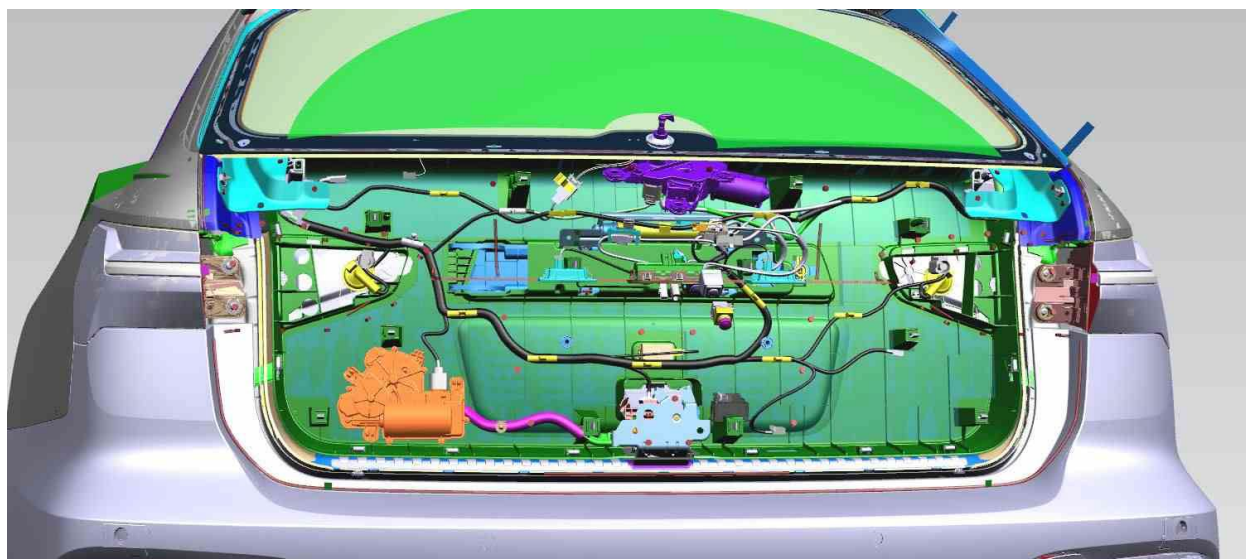
Figure 2. Carefully knock in the area of the closing assist motor. Its location varies and is model specific.

1. If it is not possible to open the power rear lid using the vehicle key, the interior/exterior buttons, or the emergency release, carefully knock with your hand on the rear lid in the area of the closing assist motor (Figure 2). The resulting vibrations should release the blockage within the closing assist motor.
