Technical Service Bulletin

94 Rear lights do not switch from bumper to hatchgate

94 24 71 2050073/2 February 14, 2024. Supersedes Technical Service Bulletin Group 94 number 18-95 dated January 19, 2018 for reasons listed below.

Model(s)	Year	VIN Range	Vehicle-Specific Equipment
Q3	2015 - 2018	All	Not Applicable

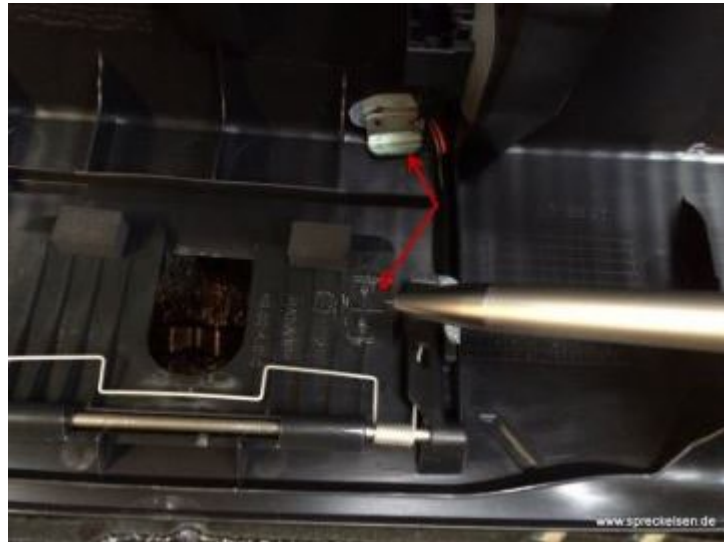
The root cause of this problem may be due to a signal malfunction from the G525 hall sensor. This sensor is located in the rear lock carrier trim.

A hall sensor or sensor induction plate is faulty or improperly mounted or broken away from the trim.

Figure 3. Broken induction plate.

Monitoring the measured values will confirm the G525 hall sensor as the root cause. If this is the case remove the rear lock carrier trim and carefully inspect the latch entry door operation, hall sensor mounting, and induction plate mounting. If the rear lock carrier trim is damaged causing a loose or compromised fit of components it will need to be replaced.

The G525 rear lid closed sensor is available as a separate replacement part if found to be faulty. The rear lock carrier trim need not be replaced in cases where no damage to the trim is found.

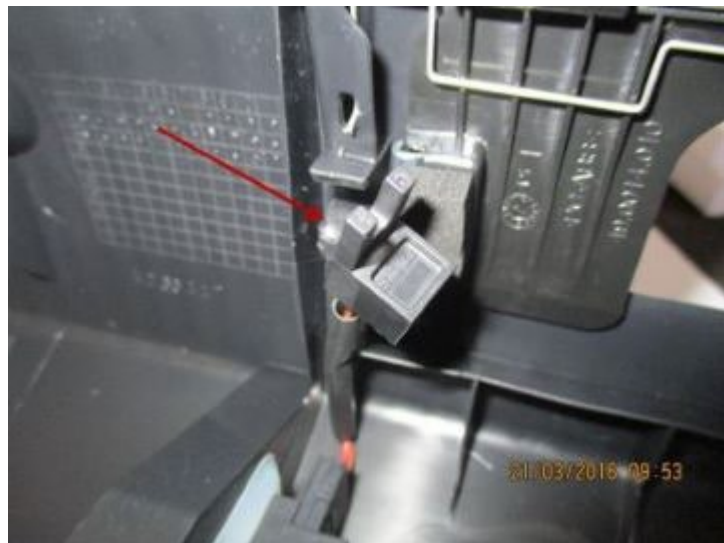
Figure 4. Loose G525 hall sensor.

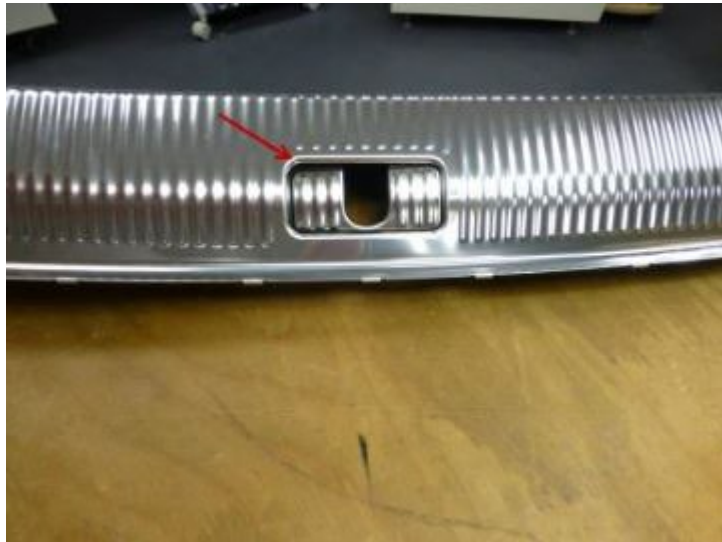
The latch entry cover on the rear lock carrier trim is broken.

Figure 5. Damaged latch entry cover.

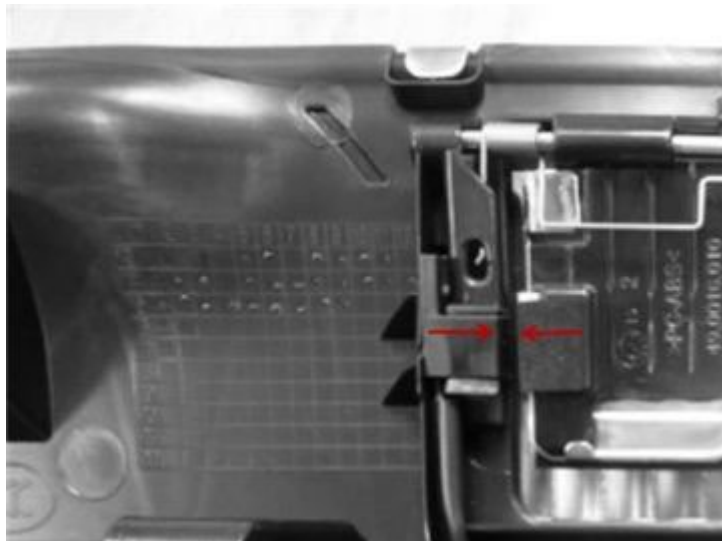
The air gap between the G525 hall sensor and the induction plate exceeds 1.6 mm

Figure 6. Excessive hall sensor to induction plate air gap.

- Strengthened rear lock carrier trim with additional support for the hall sensor and induction plate mounting.
- Air gap between hall sensor and induction plate reduced to 1.4 mm.
