Service Bulletin

Bulletin No.: 22-NA-193

Subject: Information on Malfunction Indicator Lamp (MIL) Illuminated - DTC P219A and/or P219B Set

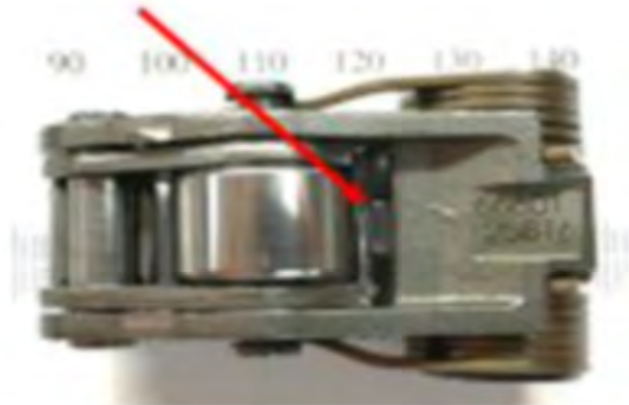
5924237

1. Remove the cam cover of the affected bank (A is Bank 1, B is Bank 2) to inspect the dual function stationary hydraulic lash adjusters for cylinder 5 or cylinder 2.
 2. Inspect the SRFFs and rocker assemblies to see if they have become dislodged or damaged.
- ⇒ While inspecting the rockers, it will be necessary to rotate the engine over by hand to ensure that the rockers are opening the valves.
- Note:** Camshaft carrier assembly removal will be necessary to fully inspect the rockers and SRFFs.
- ⇒ Below are pictures of possible SRFF failures. If any one of the SRFFs are damaged, it will be necessary to replace all four on the affected cylinder.
3. Replace the stationary hydraulic lash adjuster's (SHLA's) and the damaged Switching Roller Finger Followers (SRFF) on the bank found to have the concern.

4. If any of the conditions listed above have been verified, refer to the Service Procedure listed in SI for replacement of the Switching Roller Finger Followers (SRFF) and dual function stationary hydraulic lash adjusters for cylinder 5 or cylinder 2.
