SIB 63 05 23

DAYTIME RUNNING LIGHT IS DIM OR DISCOLORED

This Service Information Bulletin (Revision 1) replaces SI B63 05 23 dated April 2023.

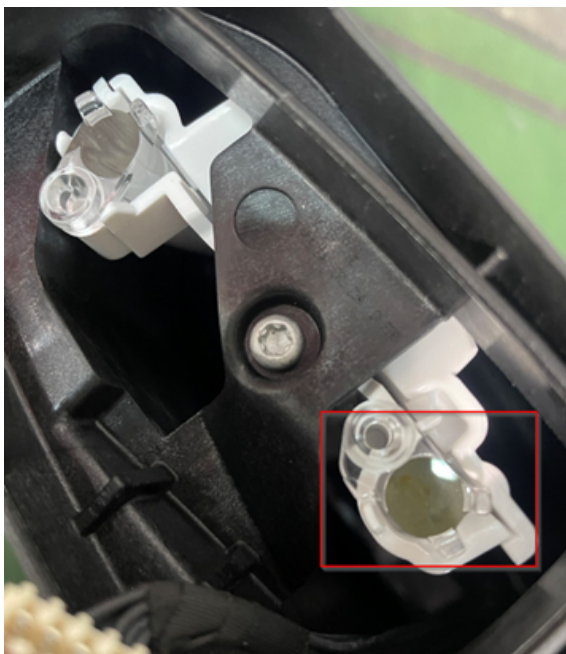
One or more of the LED daytime running lights are dim or discolored, such as this example in which the inner light is “yellowed”.

The connection between the LED module and the light tube inside the upper/top headlamp housing is damaged.

2. Inspect the upper/top headlamp and LED module for signs of discoloration as shown in the photo.

Inspect and replace the affected LED module and the upper/top headlamp housing.

Note: If discoloration is seen, the affected upper/top headlamp and LED module require replacement.
