SIB 61 30 23

## DELIVERY STOP: INTERACTION BAR

**MODEL**

| E-Series | Model Description | Production Date |
|---|---|---|
| G70 | 7 Series Sedan | November 10, 2022 – March 28, 2023 |

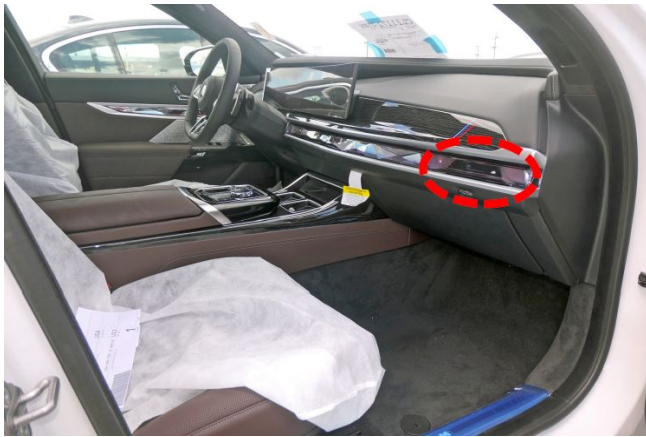
In the event of a voltage drop, comfort functions of the interaction bar may fail and not respond.

Software error in the BMW Interaction Bar.

This can lead to a failure of the air vent functions on the passenger side of the bar (circled).

Replace the BMW Interaction Bar **before vehicle delivery**.

Replace the BMW Interaction bar following repair instructions, **Removing, and installing the touch control box for the instrument panel 61 31 147 | REP-REP-P-6131147-G70 - V.4.**
