Service Bulletin

Bulletin No.: 23-NA-216

Subject: Rattle Noise from Exhaust

Brand:	Model:	Model Year:		VIN:		Engine:	Transmission:
		from	to	from	to		
Chevrolet	Camaro	2018	2024	—	—	3.6L (LGX)	—

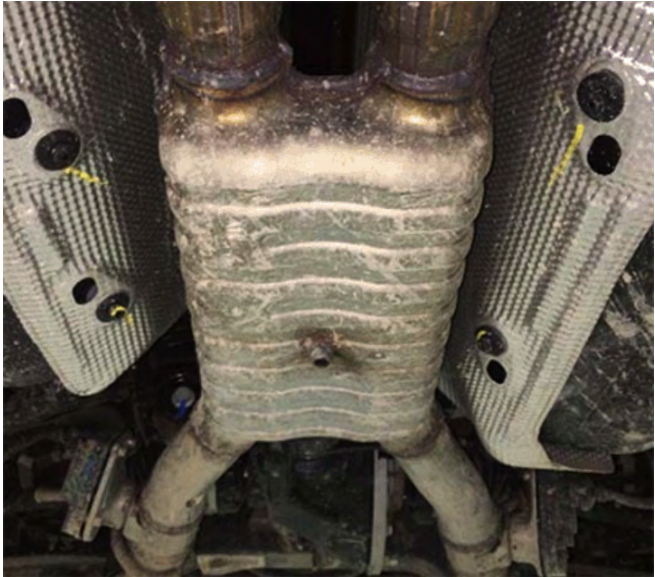
5124927

Involved Region or Country	North America, Argentina, Brazil, Bolivia, Chile, Colombia, Paraguay, Peru, Uruguay, Europe, Russia, Middle East, Israel, Palestine, Japan, China, Taiwan, Thailand, Philippines, Other Africa
Condition	Some customers may comment on an exhaust rattle noise heard coming from the vehicle. Technicians may automatically look at the exhaust valves for noise concerns.
Cause	<p>This condition may be caused by the exhaust resonator.</p>

Note: Corrosion alone will not cause this concern. The quality of the actual welds is the issue. Dealership technicians are to inspect both the lower weld on the bottom of the resonator, as well as the upper weld on top of the resonator for signs of cracking.

Inspect the lower weld on the bottom of the resonator, as well as the upper weld on top of the resonator for signs of cracking. If the concern listed above has been found, replace the rear portion of the exhaust system.

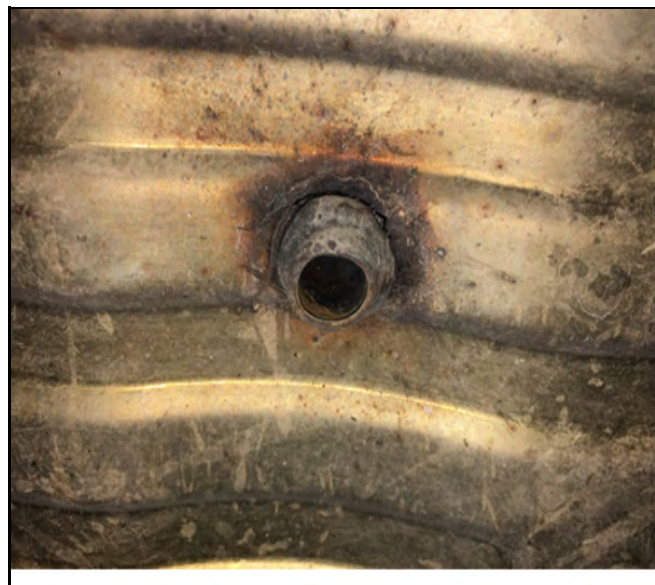
5118372

- There is a tube located in the center of the resonator as shown in the graphic above. This is NOT a drain tube for condensation inside the exhaust system. This pipe is a structural component of the resonator that stiffens the upper and lower halves of the assembly. The welds holding this tube in place may crack, resulting in a rattle noise that can be heard by the owner of the vehicle. This will be most noticeable when starting the engine and/or applying the throttle.
