February 15, 2024

Version 2

Squeaking or Cracking from Front of Vehicle Going over Bumps

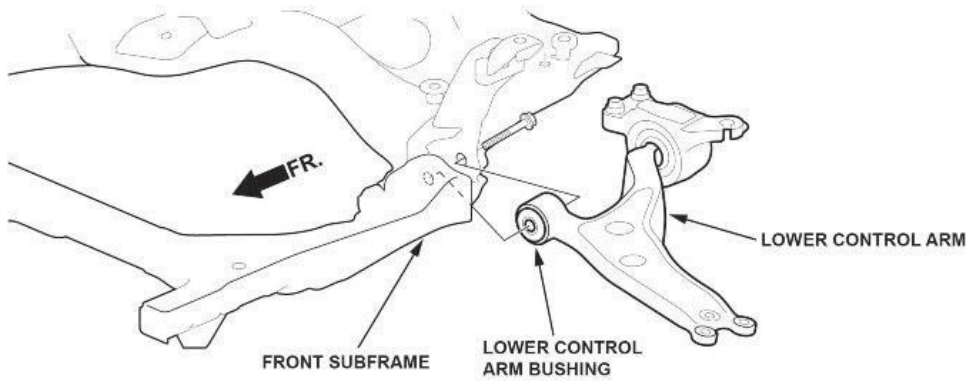
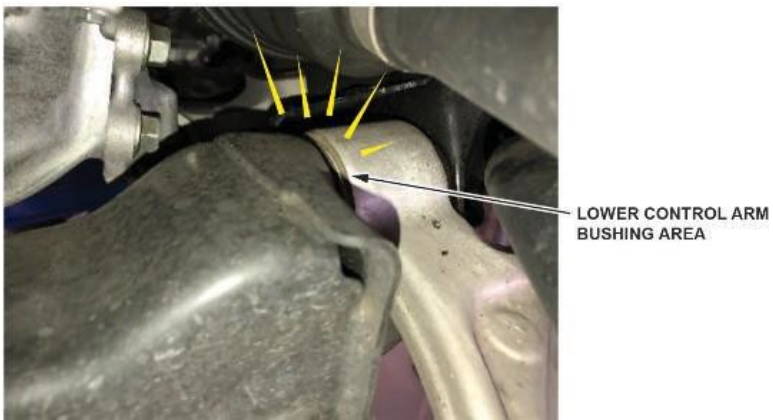
The rubber in the right or left lower control arm bushing is contacting the front subframe.

Using a ChasisEar, make sure the noise is coming from the lower control arm bushing. Isolate the noise to either the left, right, or both control arms, then replace the affected parts.

Replace the lower control arm.
