SIB 61 27 23

2024-02-22

CONDITIONED BASED SERVICES (CBS) DATA IS NOT STORED IN THE VEHICLE KEY

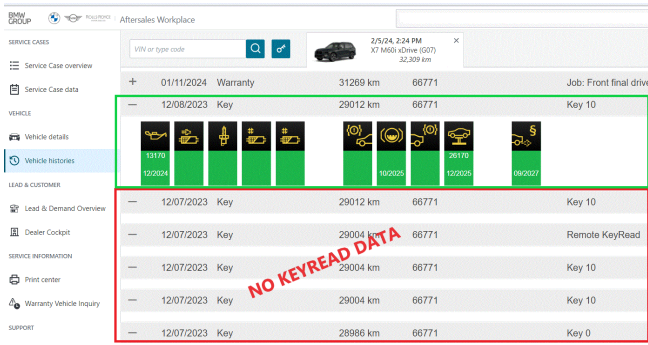
- Keyread data available highlighted in **green**.
- Keyread data not stored in vehicle key highlighted in **red**.

4. Is the CBS data now stored in the vehicle key as depicted above, highlighted in **green**?
