Subject: Information on Service Emissions System Displayed on Drivers Information Center (DIC), Malfunction Indicator Lamp (MIL) Illuminated - DTC P249C and/or P20E8 Set

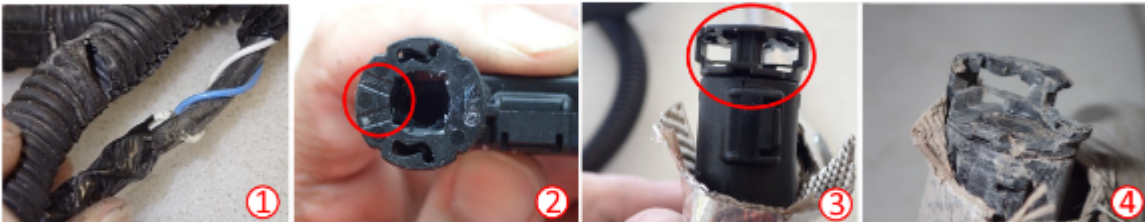
6531838

Note: Examples of a DEF pipe with damage that can not be reused. Replace the DEF pipe if this is noted.

3. Is the Emission Reduction Fluid Exhaust Front Pipe Injector Supply Pipe or the connector damaged in any way?
 - ⇒ If yes, replace the Emission Reduction Fluid Exhaust Front Pipe Injector Supply Pipe, perform a Reductant System Tamper Service Bay Test and release the vehicle back to the customer.
 - ⇒ If no, go to Step 4.
4. Follow the Cleaning Procedure outlined below and perform a Reductant System Tamper Service Bay Test, does the test pass?
 - A DEF pipe with crystallized DEF may not properly seat on the injector and may cause a leak.
 - ⇒ If yes, release the vehicle back to the customer.
 - ⇒ If no, refer to SI for the diagnostic procedure for any active DTC.

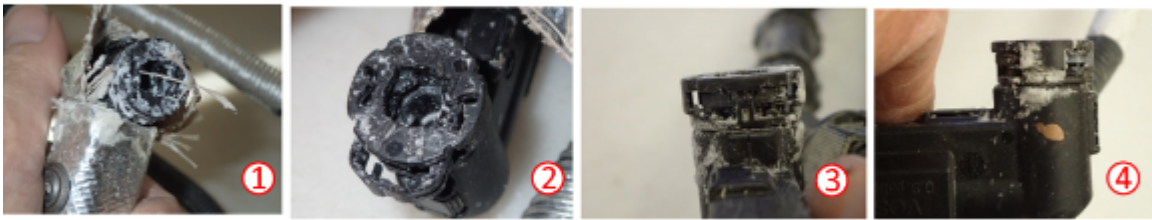
6531871

- Example of a DEF pipe with crystallized DEF. This can be cleaned using the procedure below.

The Emission Reduction Fluid Exhaust Front Pipe Injector Supply Pipe may be contaminated with crystallized DEF in or around the connector. This procedure outlines the correct cleaning procedure before attempting to re-connect the Emission Reduction Fluid Exhaust Front Pipe Injector Supply Pipe to the Reductant Fluid Injector or the Emission Reduction Fluid Pump Outlet Port.
