# Service Bulletin

Bulletin No.: 24-NA-032

**Subject:** Poor Fitting Charge Port Door and/or Charge Port Door Sticks Out at Bottom

Brand:	Model:	Model Year:		VIN:		Engine:	Transmission:
		from	to	from	to		
Chevrolet	Blazer EV	2024	2024	-	-	All	All

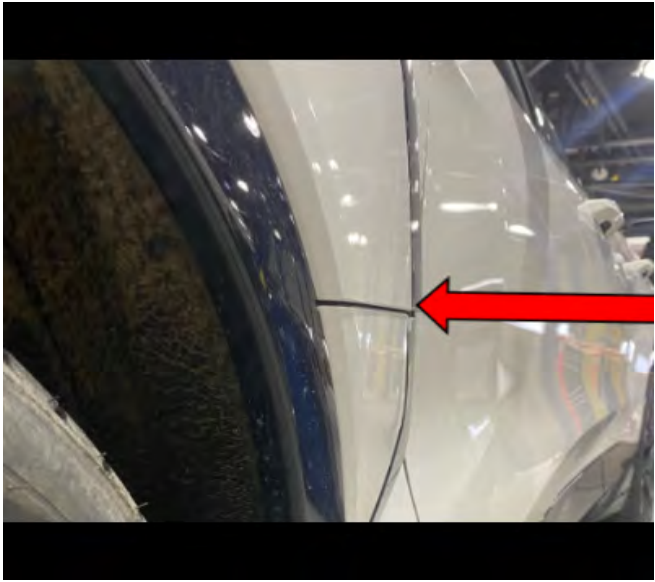
<p style="text-align: right; font-size: small;">6550658</p> <p>Some customers may comment on the charge port door not closing all the way and/or the charge port door sticks out at the bottom.</p>
<b>Cause</b>	The cause of the condition may be due to excessive material on the charge port door.
<b>Correction</b>	Refer to the procedure below to remove some of the material so that the door may close fully as intended.
