GLOBAL SAFETY FIELD INVESTIGATIONS  
DCS6806  
URGENT - DISTRIBUTE IMMEDIATELY

Subject: N232433290 - Service Update  
Engine Block Heater Cord Not Fully Seated

Models: 2024 Chevrolet Silverado 2500HD/3500HD  
2024 GMC Sierra 2500HD/3500HD  
Equipped with 8-Cylinder Duramax Diesel Engine (RPO L5P)

## N232433290 Engine Block Heater Cord Not Fully Seated

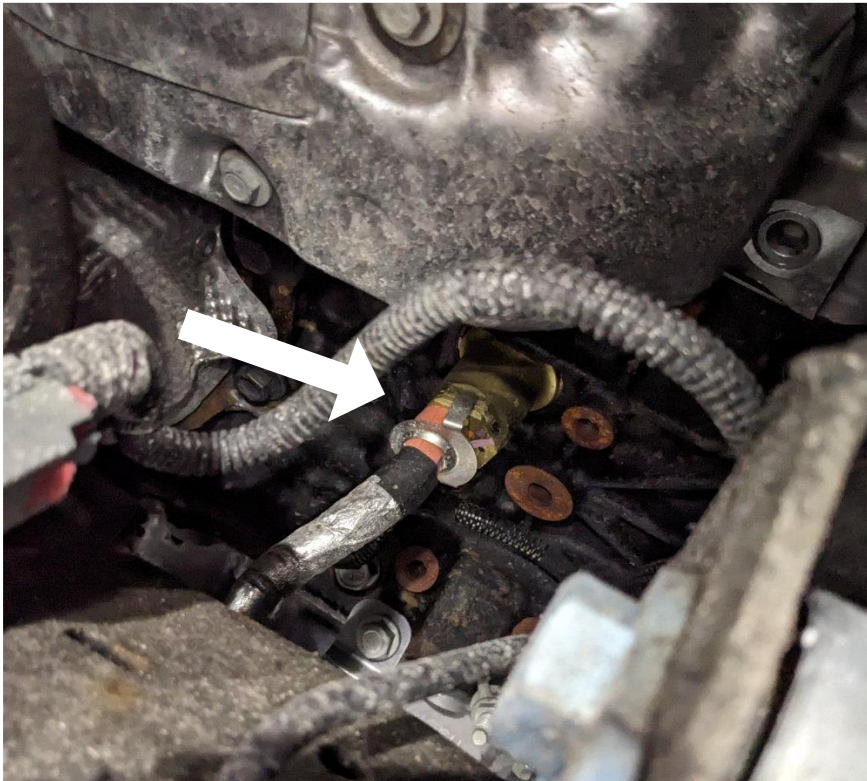
6557215

3. Locate the engine block heater through the opening in the wheel well liner.

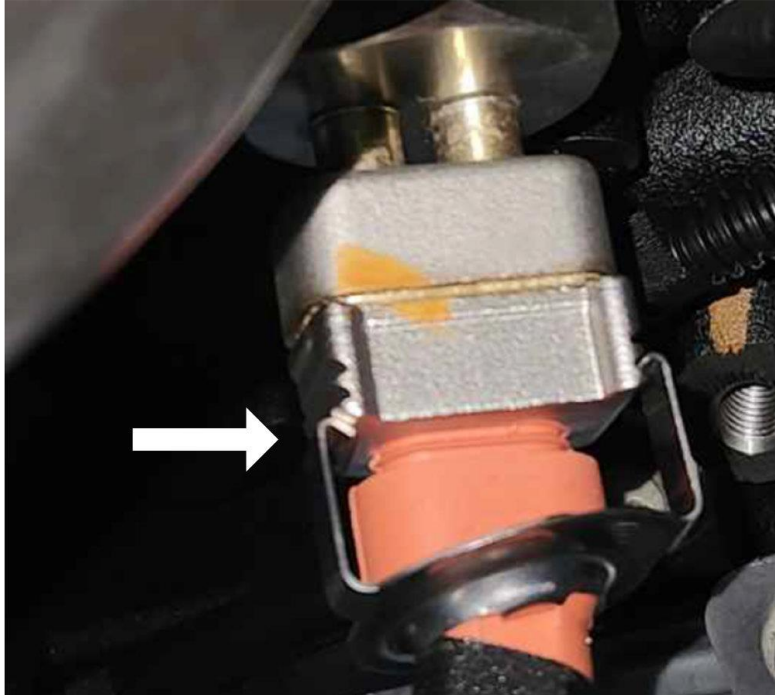
6557216

4. Inspect the engine block heater cord to be sure it is securely and evenly fastened into the engine block heater.
  - If the engine block heater is securely and evenly fastened (as step 3 shows), no further action is required. Proceed to step 8.

- If the engine block heater is NOT securely and evenly fastened (the metal ring will be at an angle relative to the block heater, and one or both sides may not be clipped in) proceed to step 5.
5. Remove the engine block heater cord from the engine block heater by unclipping the metal fastening ring around the cable.
