Service Bulletin

Bulletin No.: 24-NA-020

Date: February, 2024

Subject: Information on Service Emissions System Displayed on Drivers Information Center (DIC), Malfunction Indicator Lamp (MIL) Illuminated - DTC P249C and/or P20E8 Set

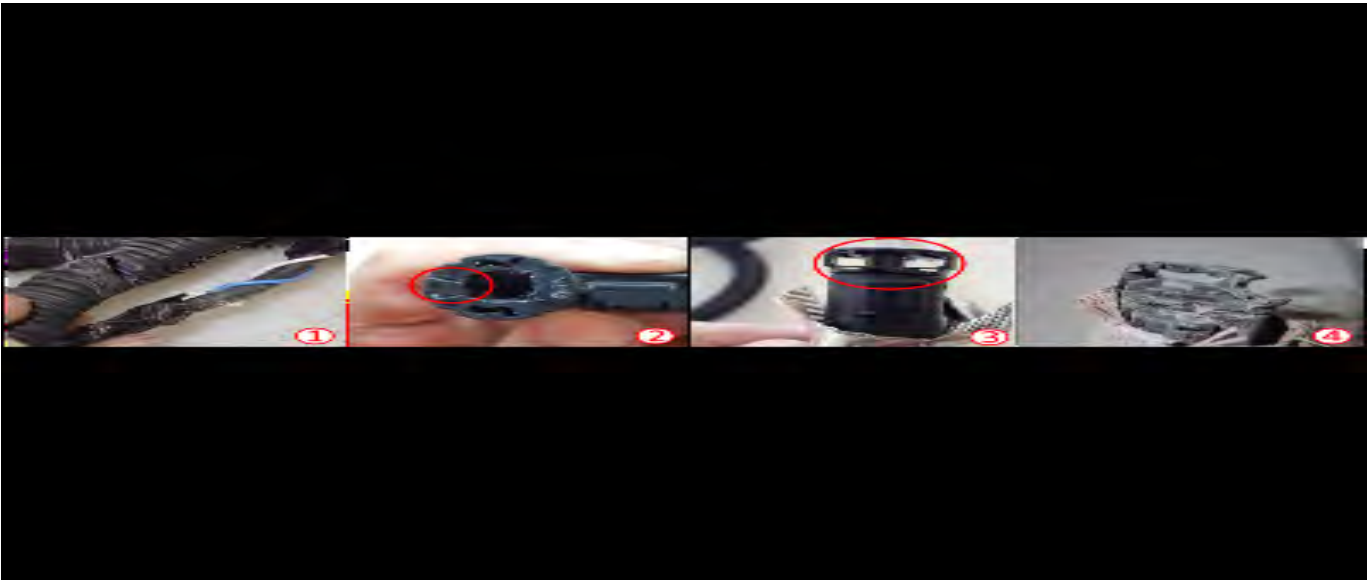
6531838

Note: Examples of a DEF pipe with damage that can not be reused. Replace the DEF pipe if this is noted.

3. Is the Emission Reduction Fluid Exhaust Front Pipe Injector Supply Pipe or the connector damaged in any way?
 - ⇒ If yes, replace the Emission Reduction Fluid Exhaust Front Pipe Injector Supply Pipe, perform a Reductant System Tamper Service Bay Test and release the vehicle back to the customer.
 - ⇒ If no, go to Step 4.
4. Follow the Cleaning Procedure outlined below and perform a Reductant System Tamper Service Bay Test, does the test pass?
 - A DEF pipe with crystallized DEF may not properly seat on the injector and may cause a leak.
 - ⇒ If yes, release the vehicle back to the customer.
 - ⇒ If no, refer to SI for the diagnostic procedure for any active DTC.

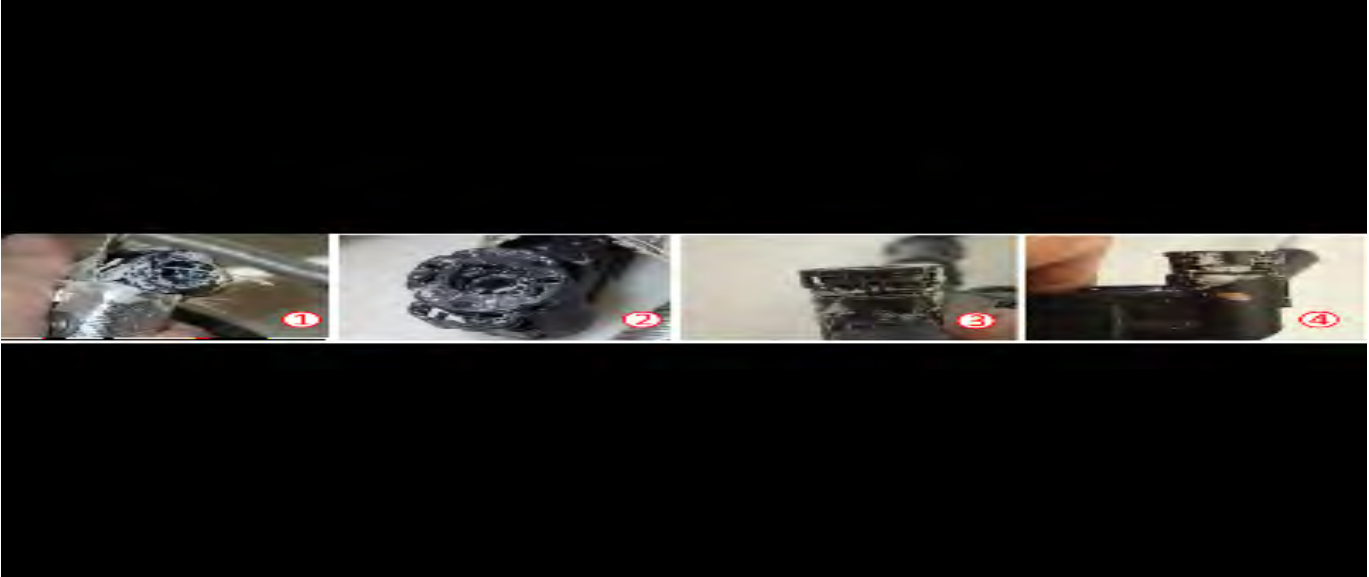
6531871

– Example of a DEF pipe with crystallized DEF. This can be cleaned using the procedure below.

The Emission Reduction Fluid Exhaust Front Pipe Injector Supply Pipe may be contaminated with crystallized DEF in or around the connector. This procedure outlines the correct cleaning procedure before attempting to re-connect the Emission Reduction Fluid Exhaust Front Pipe Injector Supply Pipe to the Reductant Fluid Injector or the Emission Reduction Fluid Pump Outlet Port.

1. Fill a clean container with fresh water.
2. Remove or pull back the heat protecting hood from the Emission Reduction Fluid Exhaust Front Pipe Injector Supply Pipe connector end if present.
3. Fully disconnect the Emission Reduction Fluid Exhaust Front Pipe Injector Supply Pipe connector from the Reductant Fluid Injector or the Emission Reduction Fluid Pump Outlet Port by following the

4. Submerge the Emission Reduction Fluid Exhaust Front Pipe Injector Supply Pipe connector end into the container filled with clean water, ensuring the open end of the connector is facing up and hold for 1 min. Swash around the connector while it is submerged in water for another minute to dislodge any crystals embedded inside the connector.

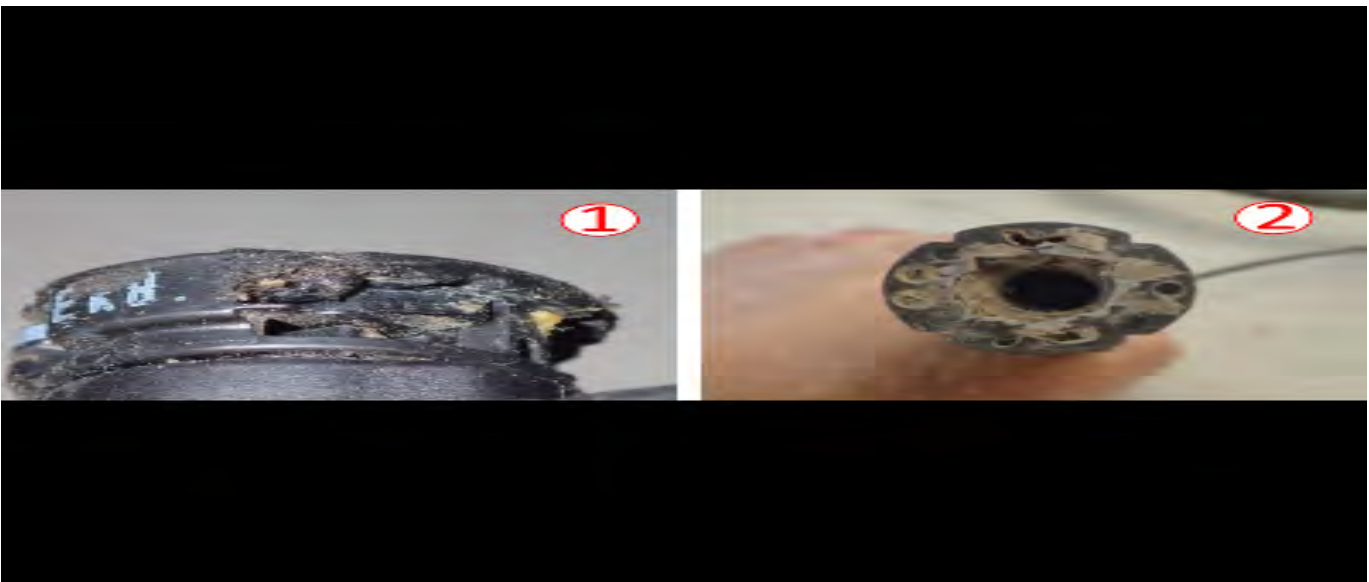
6531860

Note: This procedure cannot be performed if the Emission Reduction Fluid Exhaust Front Pipe Injector Supply Pipe connector is contaminated with other forms of contaminants such as frame wax or dirt inside the connector. If this is the case, do not perform the cleaning procedure as the Emission Reduction Fluid Exhaust Front Pipe Injector Supply Pipe will need to be replaced.
