39-20-01 - Bevel Box Case Half Leak

Release date: 2/29/2024

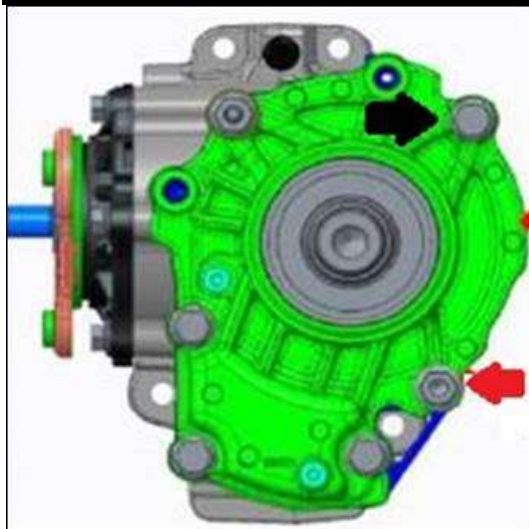
Figure 1.

Source of leak is between the case halves at the right side of the bevel box between the two bolts seen in Figure 1 (red and black arrows).
