Technical Service Bulletin

91 MIB2 High: rearview camera/overhead view camera does not turn on

91 24 78 2055026/7 February 23, 2024. Supersedes Technical Service Bulletin Group 91 number 21-99 dated May 4, 2021 for reasons listed below.

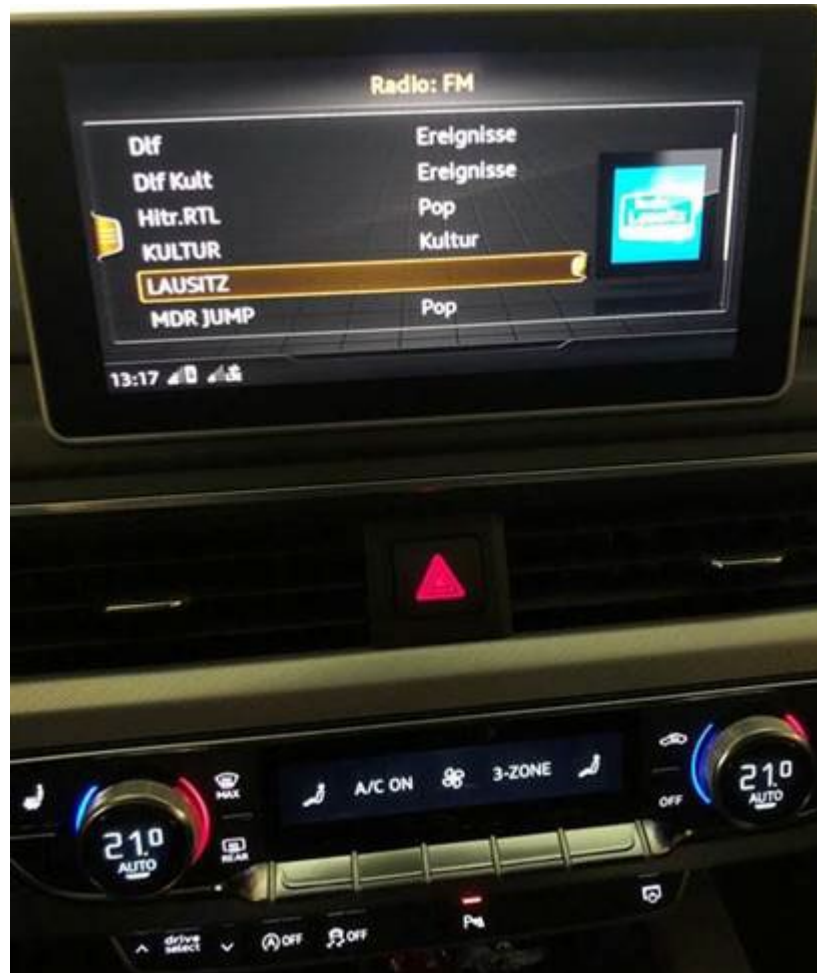
For vehicles with < 0318 camera software (address word 006C):

- The rearview/overhead view camera and the optical parking aid are sporadically not switched on when moving into reverse. The previously adjusted menu (radio, navigation, etc.) stays the same (Figure 1).
- The parking aid button in the center console lights up and an acoustic obstacle warning is given.

Figure 1. Previously adjusted menu stays the same (vehicles with camera software < 0318).

The MIB2 High software needs to be updated.

Update the MIB2 High infotainment system using either Method 1 or Method 2 according to TSB 2047576: *91 MIB2 High Software Update Instructions (PR Code 7UG)* and use SVM code indicated below:

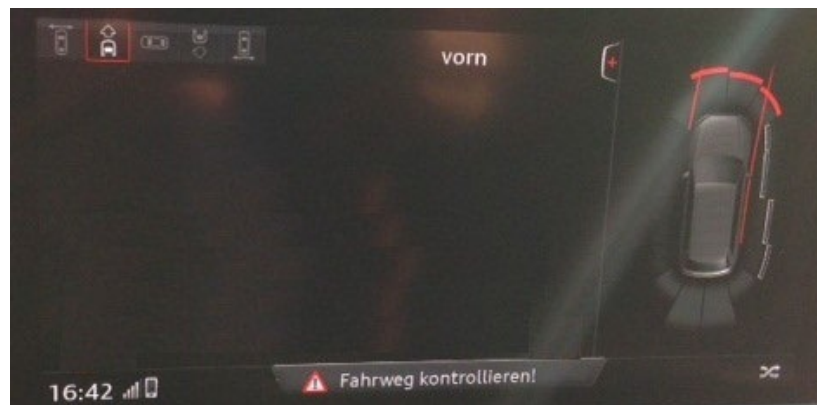
For vehicles with camera software >= 0318 (address word 006C):

- The picture of the top view camera is black and no guide lines are shown (Figure 2).

Figure 2. Camera picture without guidelines (vehicles with camera software 0318).
