Service Action Code: 87H9

Pressure & Temperature Sensors

On vehicles manufactured within a specific period, the pressure and temperature sensors in the air conditioning system may fail. If this happens, the air conditioning system will no longer function.

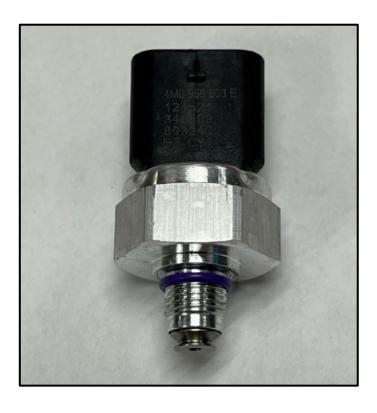
- Inspect G395 and G826 pressure/temperature sensors.
- Replace if necessary.

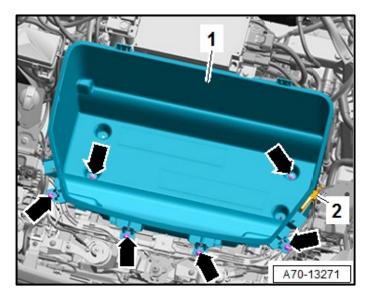
- Remove front luggage compartment liner <1> per the ELSA repair manual:
 - Repair manual > Body > Body Interior > Interior Trim > Luggage Compartment Trim Panels > Front Luggage Compartment Liner, Removing and Installing

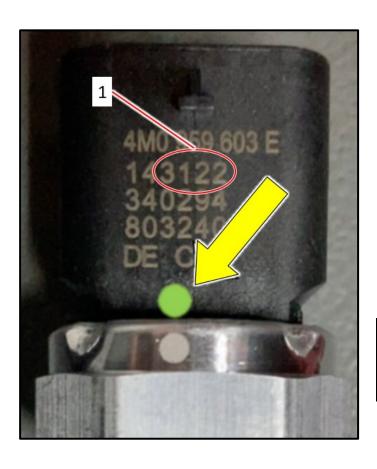
- Check for a green dot <arrow> on the connector housing of the G395 and G826.
- If the green dot is present on both sensors:
 - The sensors do not require replacement.
 - o Continue with the reassembly instructions in this section.
- If the green dot is NOT present on the sensor(s):
 - Check the production date <1> of the affected sensor.
 - If the affected sensor was produced calendar week 23 of 2020 through calendar week 30 of 2021, the sensor must be replaced.

The production date <1> of the sensor pictured is calendar week 31 of 2022. This sensor does not require replacement. The date format is week/year.

- If a sensor requires replacement:
 - o Proceed to section C.
- If both sensors are ok and do not require replacement:
 - Continue with the reassembly instructions in this section.

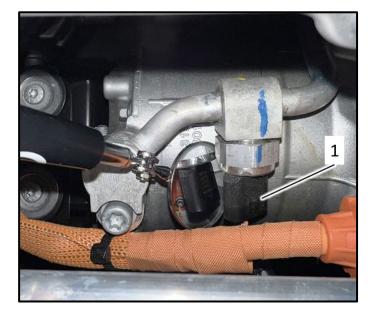
If either sensor is positioned in a way that the production information is not visible on the connector <1>, a mirror can aid in inspecting the sensor.
