SERVICE PROGRAM BULLETIN

APPLICABILITY: 2023 MY Legacy
2023 MY Outback

NUMBER: WRI-22R

SUBJECT: Telematics DCM Replacement

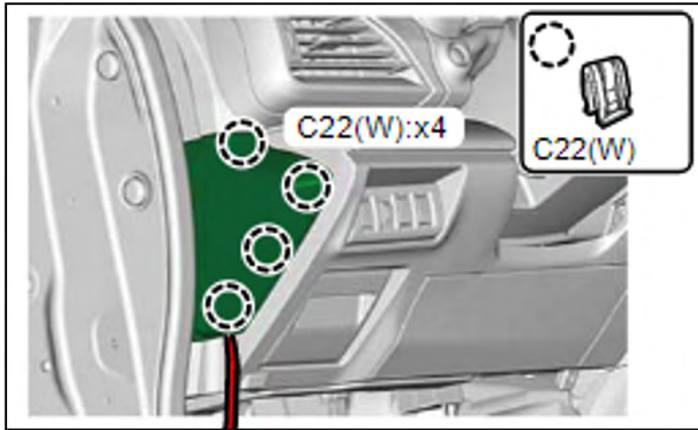
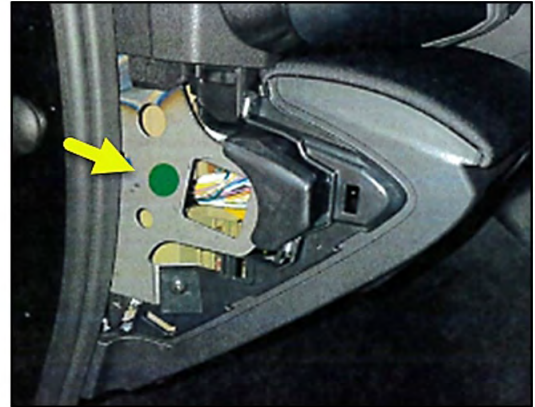
NOTE: If a **GREEN** sticker is present, STOP. This vehicle has the latest DCM, and is not affected by the WRI-22 service program.

STEP 3: Release the four mounting clips securing the driver side instrument panel side cover. Once released, remove the cover.

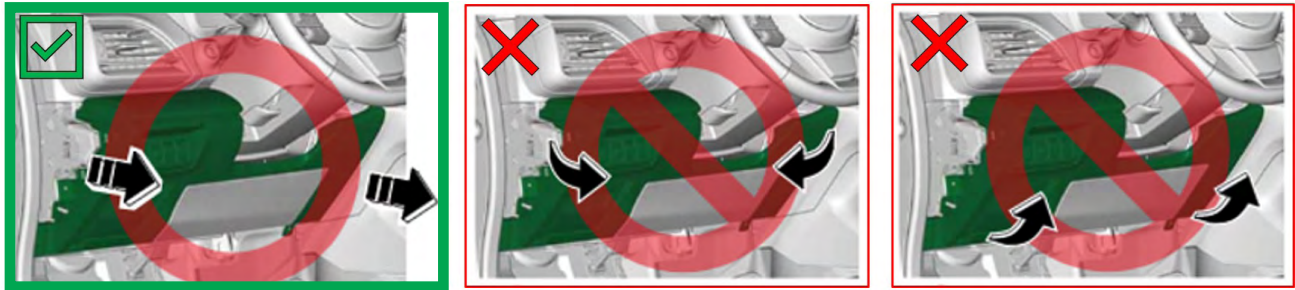
CAUTION: When removing the lower driver cover, **ALWAYS** pull the cover in a straight direction. Pulling in a lateral or upward direction may cause damage to the lower driver cover.

CAREFULLY disconnect all electrical connections. Remove the lower driver cover from the vehicle.

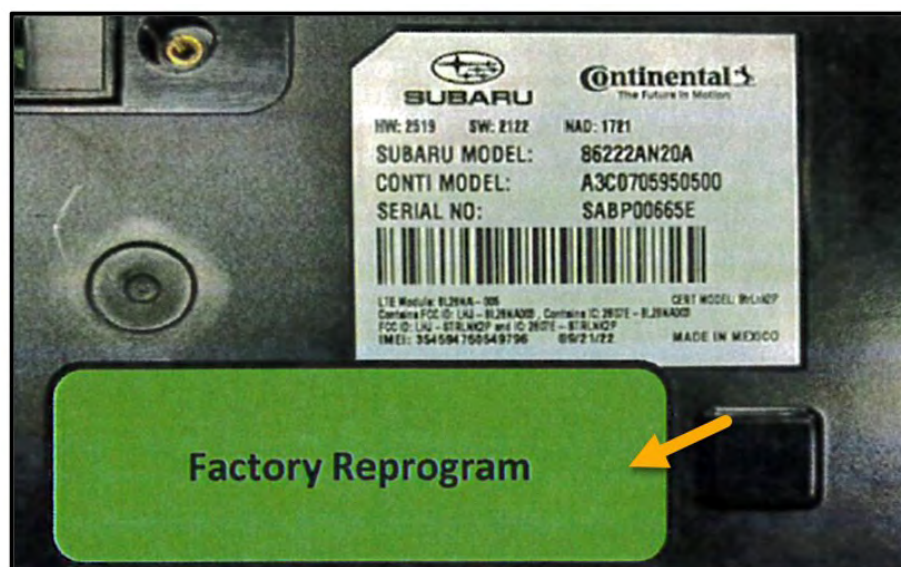
NOTE: If a **GREEN** sticker is present, STOP. This vehicle has the latest DCM, and is not affected by the WRI-22 service program.

STEP 15: Remove and properly recycle the Lithium-ion back-up battery from the original DCM. Further detail on proper battery recycling and disposal can be found on Subarunet. Refer to: <https://www.subarunet.com/home/communications/view/726115>
