SERVICE BULLETIN

APPLICABILITY: 23-24MY Outback/Legacy Models (including Wilderness models)
 23-24MY Ascent Models
 24MY Impreza
 24MY Crosstrek
 24MY WRX

NUMBER: 15-305-22R
DATE: 11/15/22
REVISED: 02/26/24

SUBJECT: Reprogramming File Availability for Optimization of Gen 4.5 Denso CP1.5 Infotainment Systems

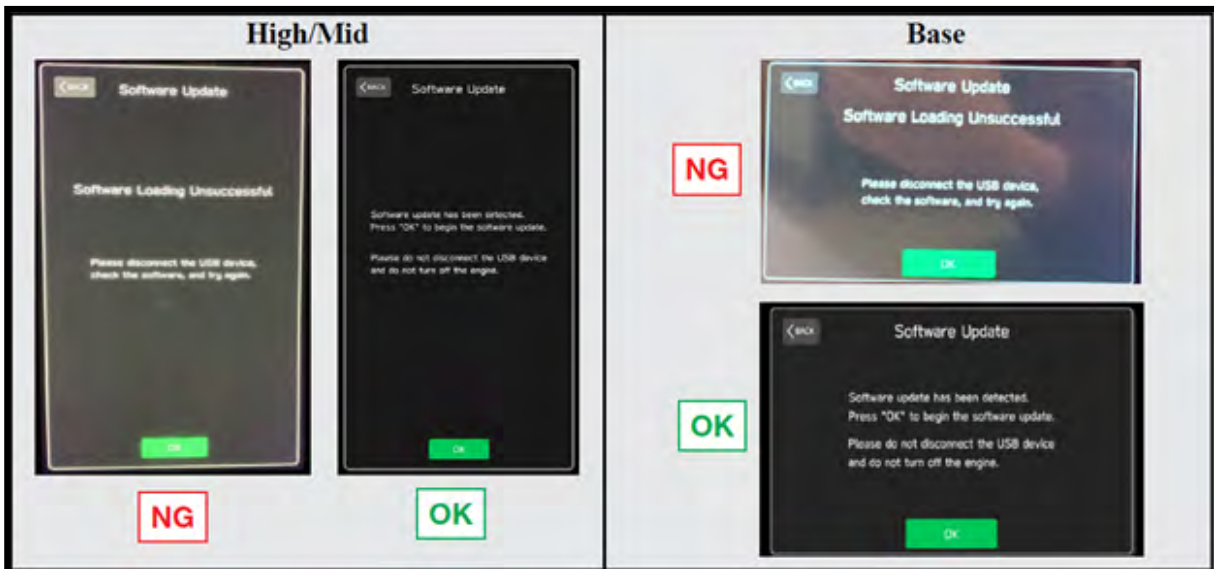
NOTE: If after plugging in the USB, the screen displays a **Software Loading Unsuccessful** message, confirm the USB device has been properly formatted and the software on the device matches the system being reprogrammed (example: Base software is being used to update a Base system) and retry.

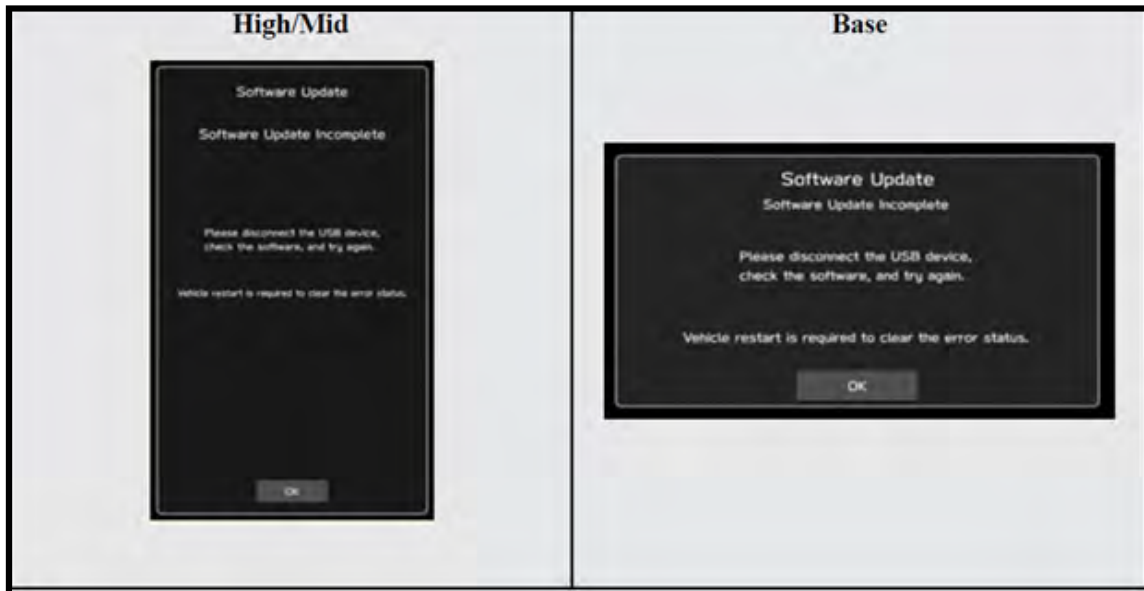
If you get the message **Software Update Incomplete** as shown below, please don't replace the hardware but retry updating the software according to the instructions in "**Appendix B**" on pg. 25.

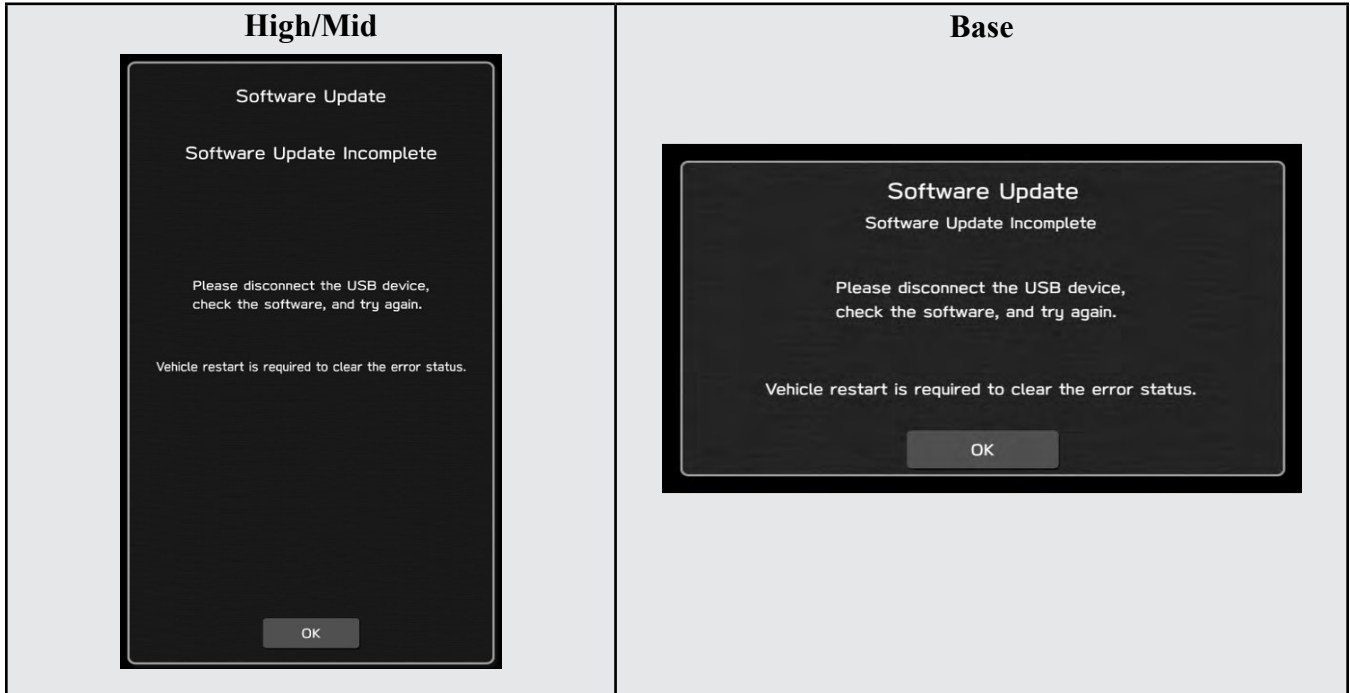
- If the first attempt of update fails with the message below, follow the steps described below 1-2 to 1-8 before retrying the software update.

1-2. Turn the ignition switch or the engine OFF, and turn it ON again.

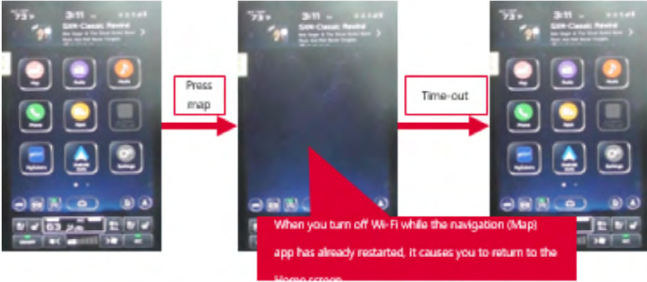
<p>- Even when pressing the Map icon the map does not appear and it remains stuck on the 'Loading Navigation' message. This issue occurs due to a corrupted file that stores settings and destination history (only applicable to HIGH trim).</p> <p>- The text keyboard which should not be displayed appears on top of the list of POI categories (only applicable to HIGH trim) when performing the steps below:</p> <ol style="list-style-type: none"> Narrowing down the search range within a specific city in the navigation destination search. Move to the POI category screen. Touch the city name input area, then the keyword input area, in that order.
