# Technical product information

<b>Topic</b>	Bentayga V8 Kovomo - DTC P227900 evident within the engine control unit 0001
<b>Market area</b>	United States E05 Bentley USA and rest America (6E05)
<b>Brand</b>	Bentley
<b>Transaction No.</b>	2071575/2
<b>Level</b>	EH
<b>Status</b>	Approval
<b>Release date</b>

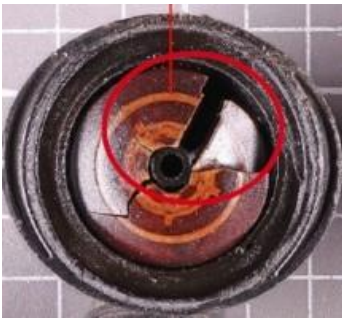
Figure 1

The issue described is due to a split breather diaphragm in one or both of the turbocharger full load pipes (Figure 1)

**The diaphragm of the bank 1 turbocharger full load pipe is located at the end of the pipe and can be easily located however the diaphragm of the bank 2 turbocharger full load pipe is installed within the pipe and therefore will not be visible**

Hint: the breather diaphragm could be split/damaged or missing

**Hint:** The diaphragm of the A,B and E suffix parts is orange (Figure 1)

1) Referring to Rep.Gr 21 - Replace the bank 1 (right) and bank 2 (left) turbocharger full load pipes

The operative should remove any debris belonging to the original diaphragm before fitting the new replacement pipes

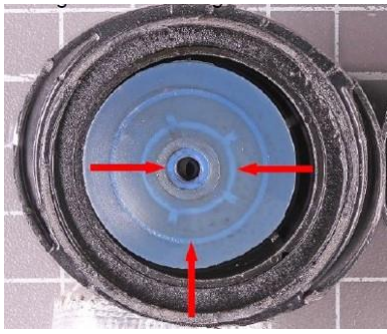
Figure 2

**Hint:** The diaphragm of 0P2 103 210G and 0P2 103 211H are blue (Figure 2)

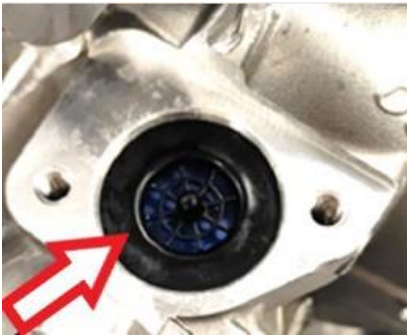
Figure 3

Production improvement was performed by fitting the diaphragm directly into the housing of the bank 1 and bank 2 turbochargers on all VINs post SJAAM2ZV3MC039237 (Figure 3)

VINs with this design are **not** subject to extended warranty

In the event the issue is evident post the suggested VIN the operative should raise a technical DISS query and await feedback before conducting any further work

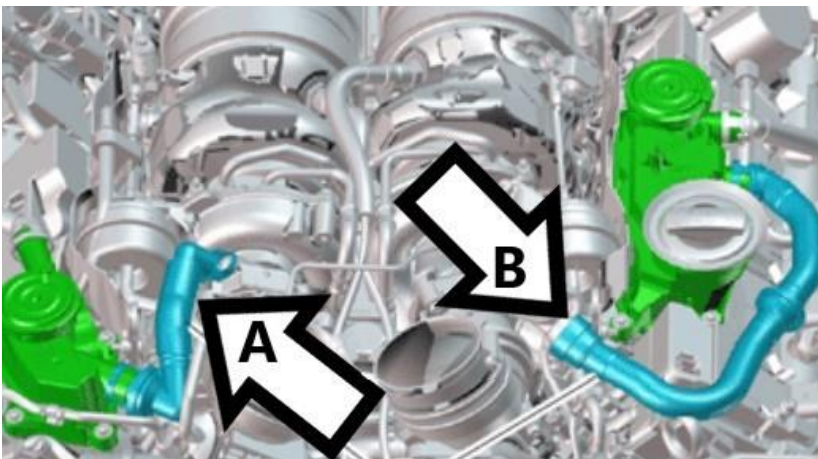
Figure 4

- Point A - Is the bank 1 (right) turbocharger full load pipe
- Point B - Is the bank 2 (left) turbocharger full load pipe

Note: when conducting the instructions within this TPI please ensure the bank 1 and bank 2 turbocharger full load pipes are replaced in pairs (during the same workshop visit)
