SERVICE BULLETIN

APPLICABILITY: 2016-18MY Legacy & Outback
 2016-18MY Impreza
 2016-18MY Crosstrek
 2016-18MY Forester
 2017-18MY WRX/STI

NUMBER: 15-316-24
DATE: 02/27/24

SUBJECT: Gen1 Telematics DCM Reprogramming for 3G Sunset

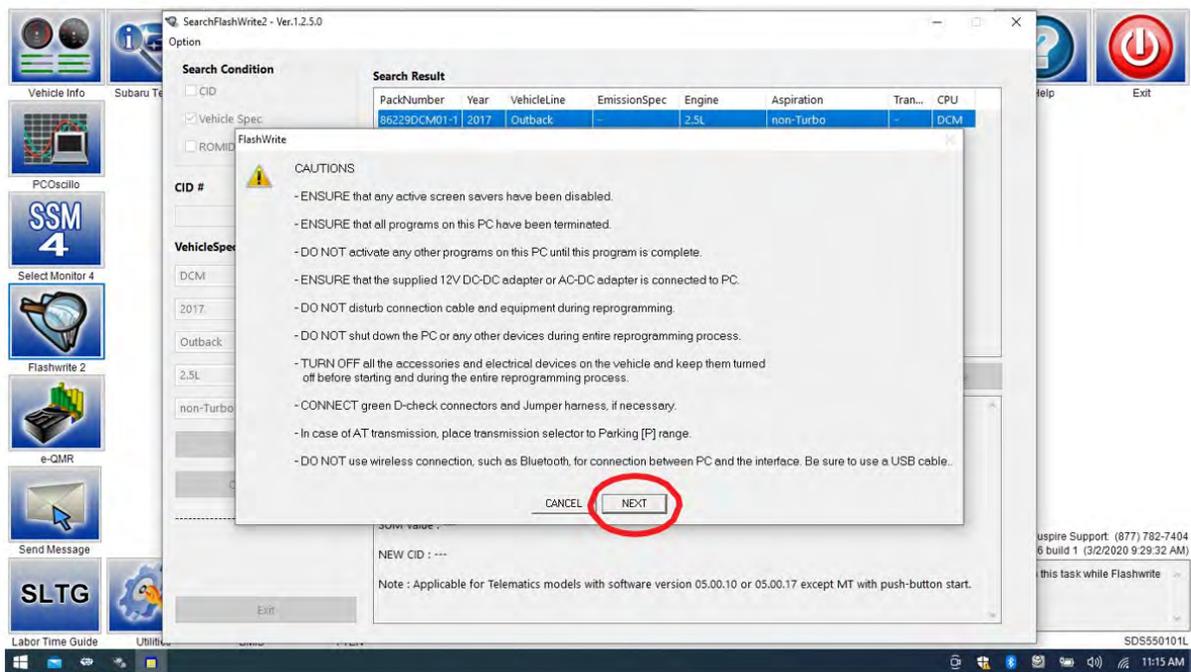
CAUTION: In the screenshot above, the on-screen directions indicate leaving the vehicle in PARK; doing this will cause the reflash procedure to FAIL. The vehicle **MUST BE LEFT IN NEUTRAL** for the entire reflash procedure. Reference page #3 above for all the vehicle conditions required for reprogramming.
