Seal, Weather Trim Strip (B-Pillar Trim) on Rear Doors Detaching

Topic number	LI72.12-P-076175
Version	3
Function group	72.12 - Rear door
Date	2/22/24
Validity	MODEL 206 206.0 FIN "F" up to manufacturing date: Jan. 18, 2023 206.0 FIN "R" up to manufacturing date: Feb. 23, 2023
Reason for change	Remedy update

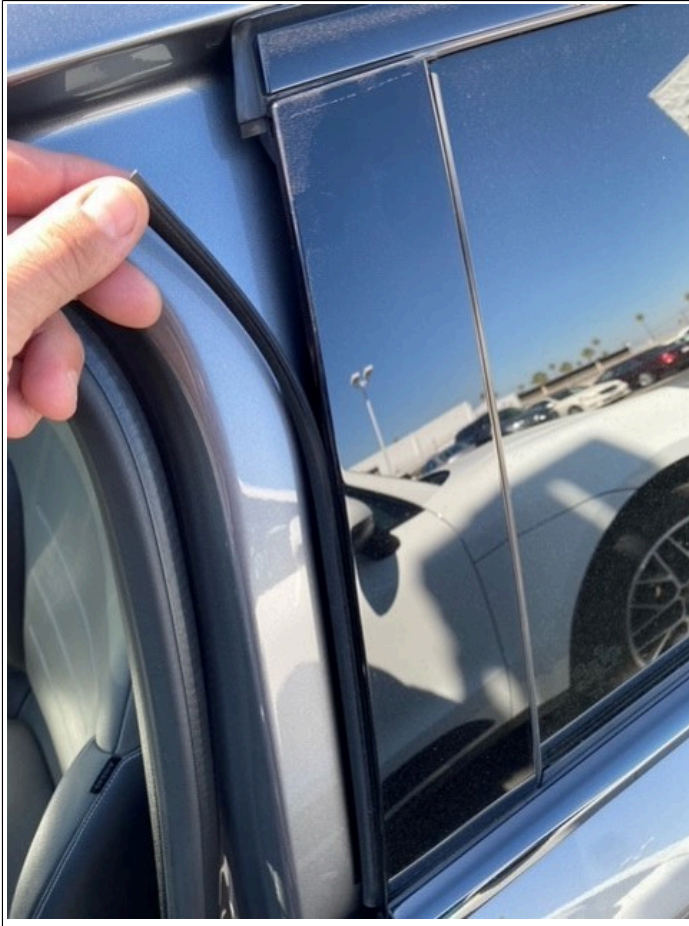
Attachments	
File	Description
Bild 1.jpg

Seal, B-pillar trim on rear doors cracked in upper area, see picture 1.

Production deviation at supplier of B-pillar trim.

Replace B-pillar trim through optimized parts.

In the event of a problem on only one door, the trim molding of the B-pillar should also be replaced on the other door.
