Campaign No. 2024010016, February 2024

SUBJECT: **Model C-Class (206 platform)**  
**Model Year 2023**

## **Inspect Weld Seam on Trunk Lid for Crack**

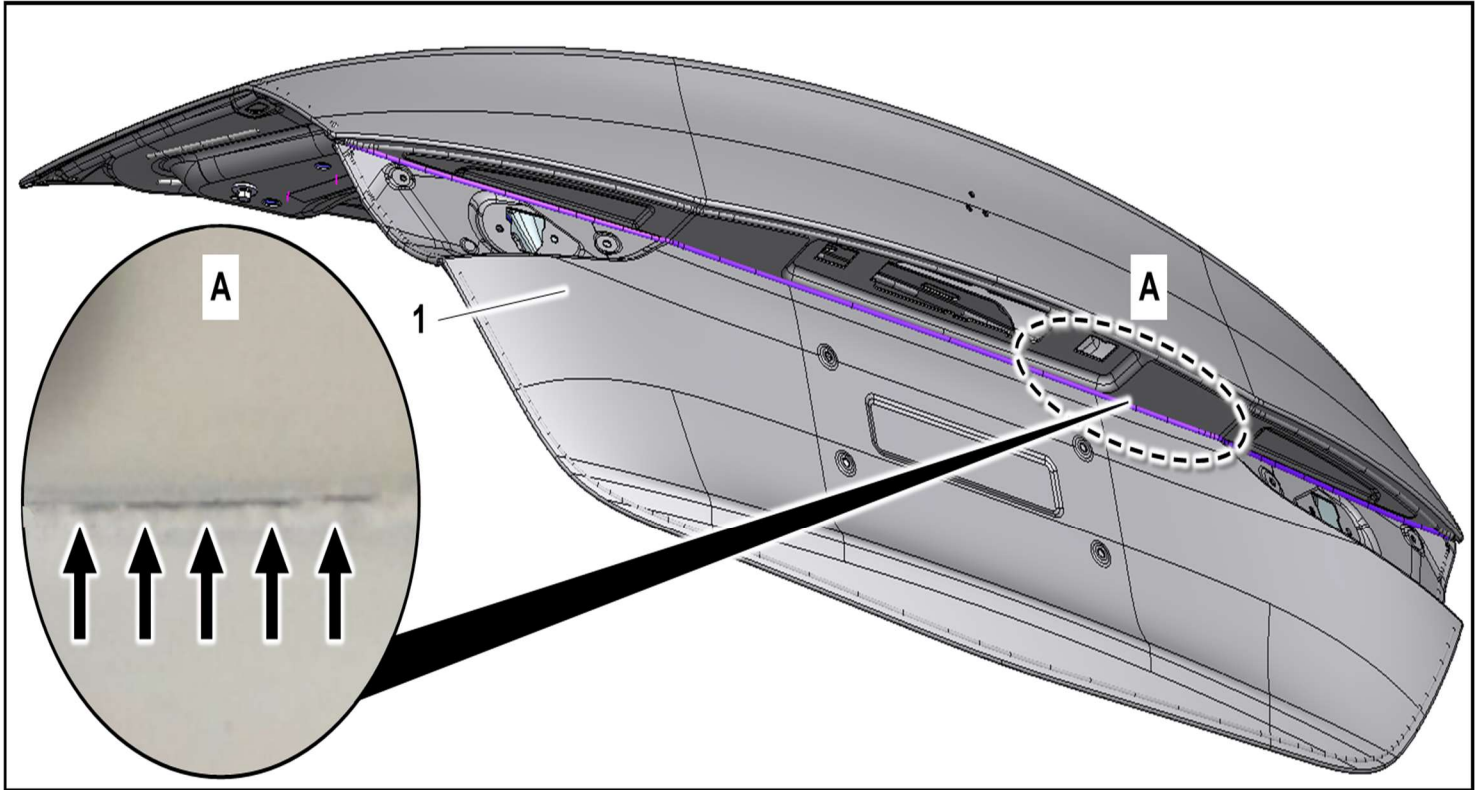
Figure 1

Mercedes-Benz AG (“MBAG”), the manufacturer of Mercedes-Benz vehicles, has determined that on certain MY 2023 C-Class (206 platform) vehicles, the weld seam on the trunk lid may not meet current production specifications. It is possible that a crack may be evident on the weld seam. An authorized Mercedes-Benz dealer will inspect the weld seam on the trunk lid and replace the trunk lid, if necessary.

1. Inspect the weld seam on trunk lid (**Figure 1, 1**) at the depicted location (**Figure 1, A**) for a possible crack.

**i** Weld seam must be checked in the direction of travel of weld.

- a. **Crack is** visible on trunk lid (**Figure 1, 1**) at specified location (**Figure 1, A**) – Carry out **Work Procedure**.
- b. **No crack** visible on trunk lid (**Figure 1, 1**) at specified location (**Figure 1, A**) – **End Measure**.

1. Replace trunk lid (**Figure 1, 1**).
