Volvo Car USA LLC

Technical Journal

<small>Technical Journal Title</small> PHEV High Voltage Battery Repairs		<small>Ref. No.</small> TJ 34295.7.1	
<small>Issuer (Dept.)</small> Technical Service		<small>Issue Date</small> 2/27/24	<small>Status Date</small> 2/29/24
<small>Car Market</small> United States and Canada	<small>Partner</small> 3 US 7510 Volvo Car USA	<small>Function Group</small> 3113	
<small>Function Description</small> Battery, high voltage		<small>Page</small> Page 1 of 8

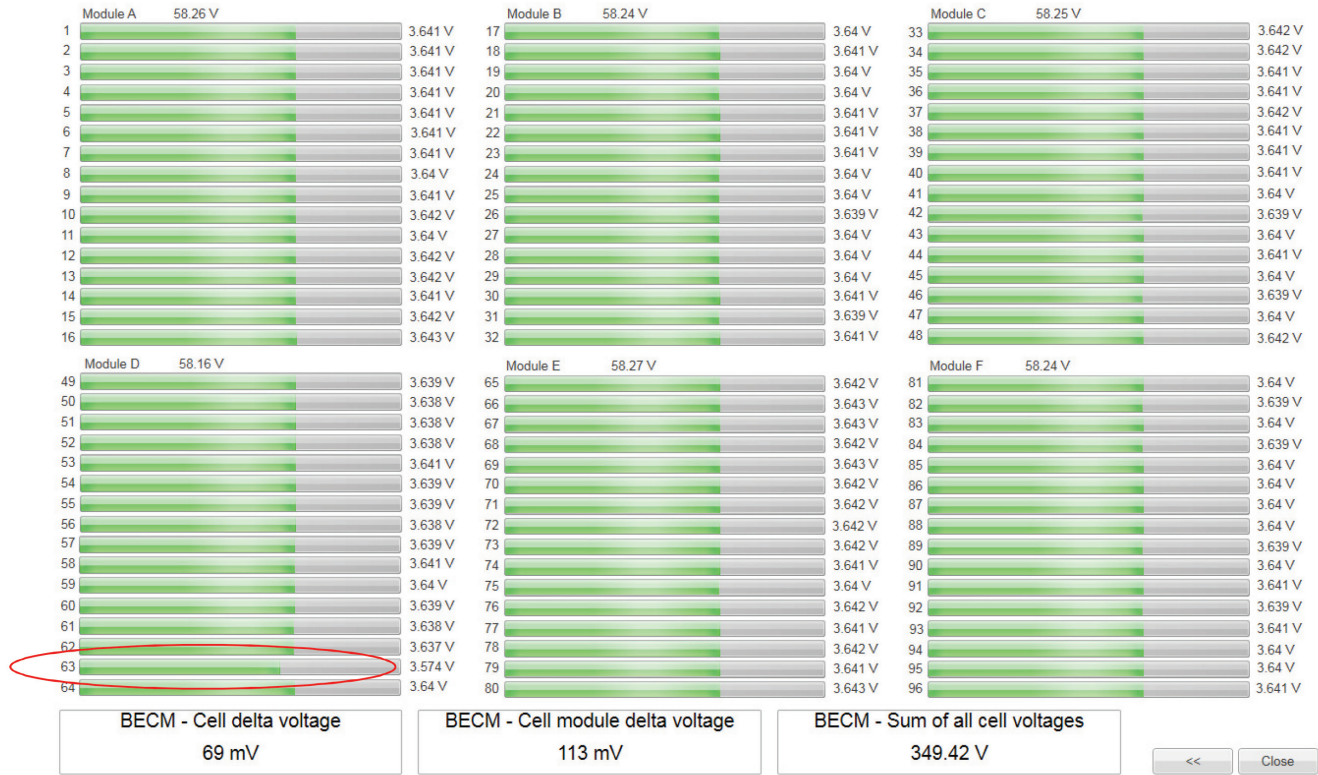
Example of Cell Fault

Cell Module: This part is most often used when one cell is defective. The most common cell defects are seen as one cell having a lower Open Circuit Voltage (OCV) and State of Charge (SoC) than all other cells. Normal SOC deviation is less than 5%, more than 10% is a fault. The cell module is delivered complete with temperature sensors and a Cell Voltage and Temperature Node. Examples are attached in "HVB - Cell Voltage Overview"

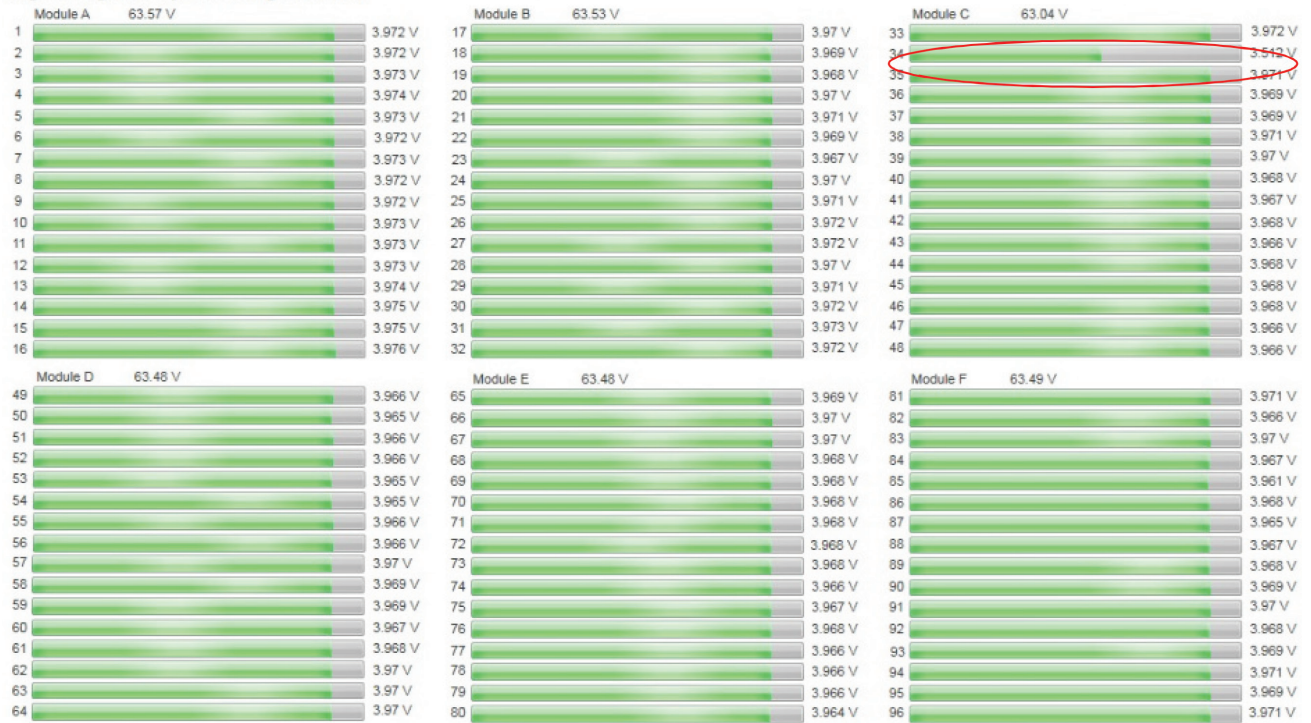
High voltage battery, cell voltage overview

Example of Cell Fault

BECM - Cell delta voltage
464 mV

BECM - Cell module delta voltage
533 mV

BECM - Sum of all cell voltages
380.59 V

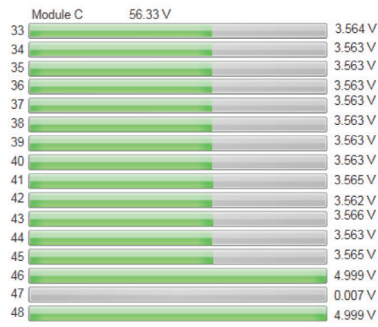
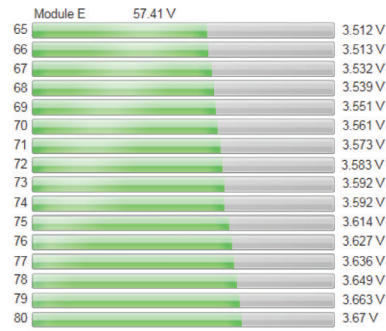
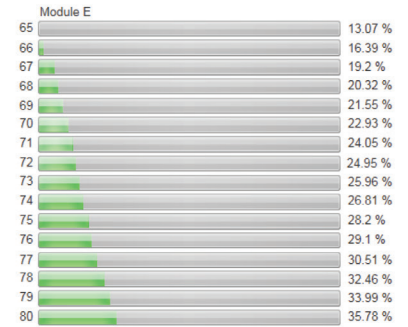
Examples of CVTN faults

CVTN (Cell Voltage and Temperature Node): This part is used when there is a DTC (Diagnostic Trouble Code) confirming an internal fault. It is also used when there is a measurement error, for example, several adjacent cells show incorrect cell voltage. Examples are attached in "HVB - Cell Voltage Overview"
