Replacement Requirement for Center Console Support: Observing Special Procedure when Replacing Component (216/23)

Model Line: **Cayenne (9YA)**

Model Year: **2019**

Concerns: **Center console support**

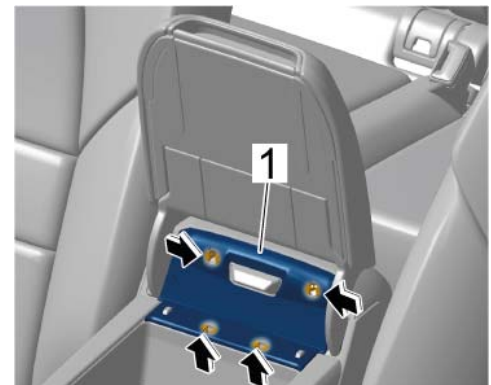
*Cover*

- Work Procedure: 1 Open cover for the tray (center armrest).
- 2 Unclip cover ⇒ *Cover -1-* using a suitable tool ⇒ *Cover -Arrows-*.
- 3 Check the number of screw connections on the cover for the tray (center armrest).

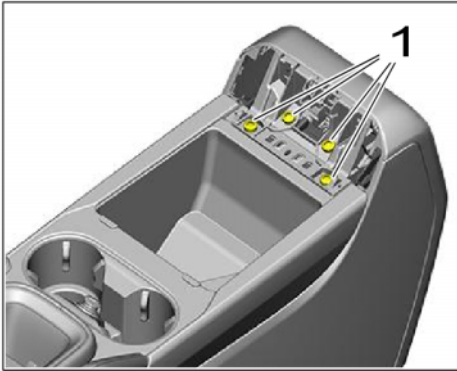
Assessment	Action
<p>There are 4 screw points ⇒ <i>New component status -1-</i>.</p>

<p><i>New component status</i></p>	<p>Replace center console support. For procedure, see: ⇒ <i>Workshop Manual '68171900 Removing and installing centre console'</i></p> <p>End of action.</p>
<p>There are 2 screw points ⇒ <i>Previous component status -1-</i>.</p>
