Campaign No. 2023090009, March 2024

SUBJECT: **Model EQS (297 platform)**  
**Model Year 2022-2023**

## **Inspect Front Left and Right Wheel Well Reinforcement**

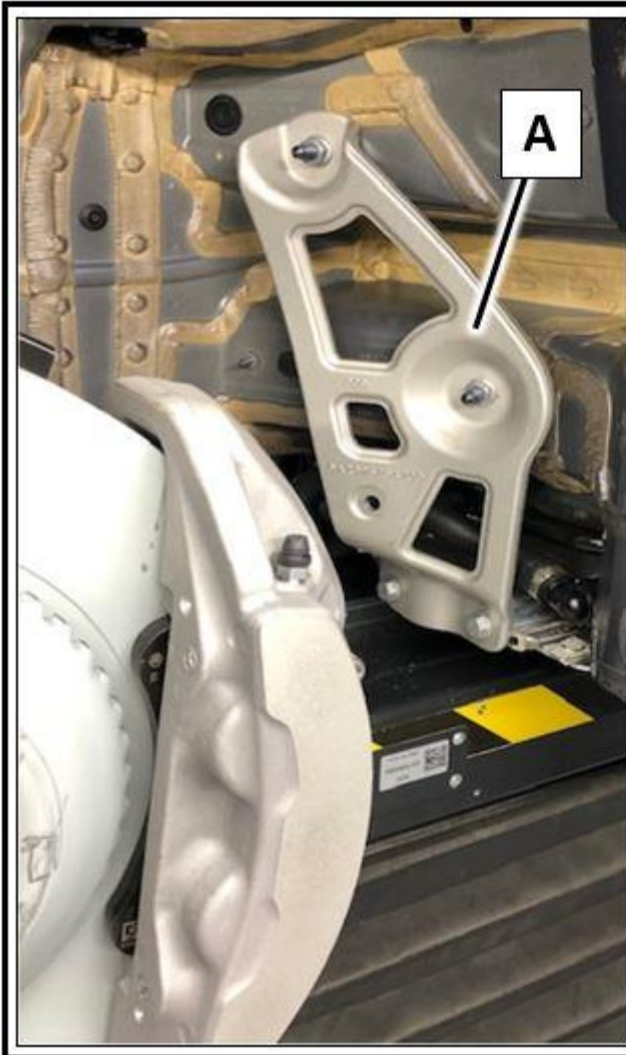
Figure 1, (Left wheel well)

1. Lift vehicle on vehicle lift.  
**i** For basic data, see AR00.60-P-1006A.
2. Remove center section of lower engine compartment lining.  
**i** For basic data, see AR61.20-P-1105EQS.
3. Visual check if reinforcement is installed in both left and right front wheel wells (**A**, Figures 1 and 2).
  - a. Reinforcement on wheel well (A) **not present**. Carry out work procedure.
  - b. Reinforcement on wheel well (A) **present**. End measure.

1. Remove front wheel and tire assembly from affected side.  
 For basic data, see AR40.10-P-1102A.
  2. Remove rear section of front fender liner from affected side.  
 For basic data, see AR88.10-P-1301EQS
  3. Retrofit reinforcement on wheel well as shown (**A, Figures 1 and 2**) on the affected side(s).  
 Tighten screw with 30 Nm torque.  
 Tighten nut with 30 Nm torque.
  4. Assemble in reverse order.
-
