PCM6 Vehicles Lose LTE Connectivity

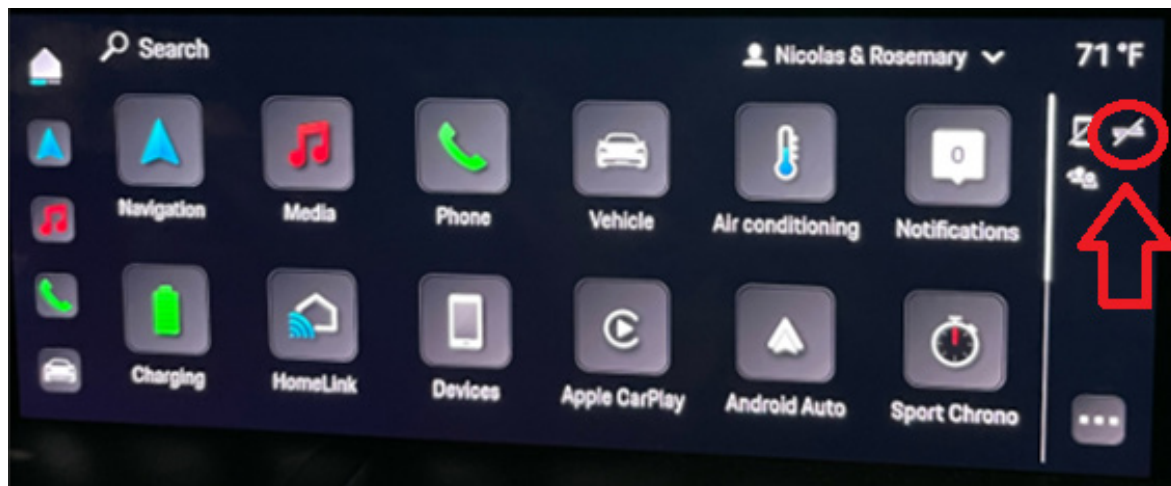
Figure 1

The customer reports that the vehicle loses LTE connectivity. On the right side of the PCM screen, the LTE icon is replaced by two opposing horizontal arrows with a slash through them. (See figure 1.) In many cases, the connectivity returns after a key cycle and workshop action is not necessary. In bad cases, the customer cannot recover connectivity and must visit the workshop.

There are errors in the operation of the ConBox. Porsche is working on a permanent fix. This issue only occurs on PCM6 vehicles (often called release 3 vehicles).

The workshop can often recover LTE connectivity by resetting the ConBox. A simple way to do this is to deactivate Flight Mode.

To do this, use the PIWIS tester to navigate to the "Connect" control unit. Select "Maintenance repairs". Then, select: "Deactivate Flight mode" and follow the on screen prompts to completion.
