January 2024
SF671A
(Revised February 2024)

Subject: Beverage Body Frame Rail 50 KSI

Models Affected: Specific model years 2015-2023 Freightliner Business Class M2 vehicles manufactured January 9, 2014, through December 22, 2022.

Work Instructions

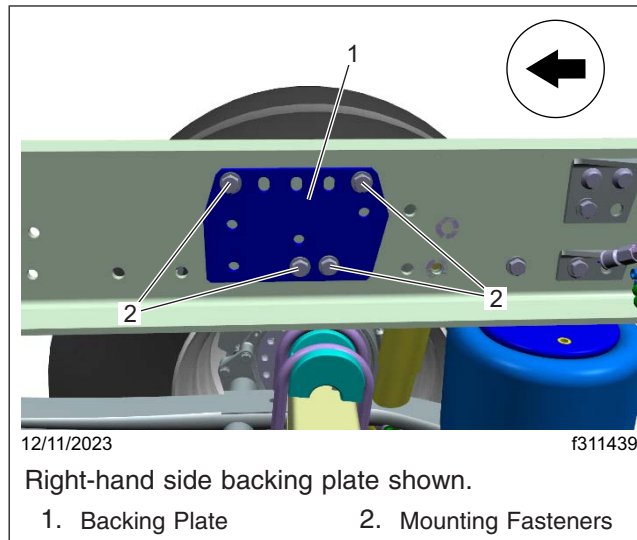
Fig. 6, Lateral Control Rod Backing Plate

- Inspect the frame rail carefully at the location of the lateral rod backing plate. Assess/repair any cracks that are detected in the frame rail web. For instructions, see **Group 31** of the *Business Class M2 Workshop Manual*.

If cracks are detected in the frame rail flange or the bend radius area, replace the right-hand frame rail. Please contact your DTNA District Service Manager for clarification and approval.

- Remove the fasteners that attach the lateral control rod backing plate to the right-hand frame rail, as shown in **Fig. 6**. Remove and discard the right-hand side backing plate.

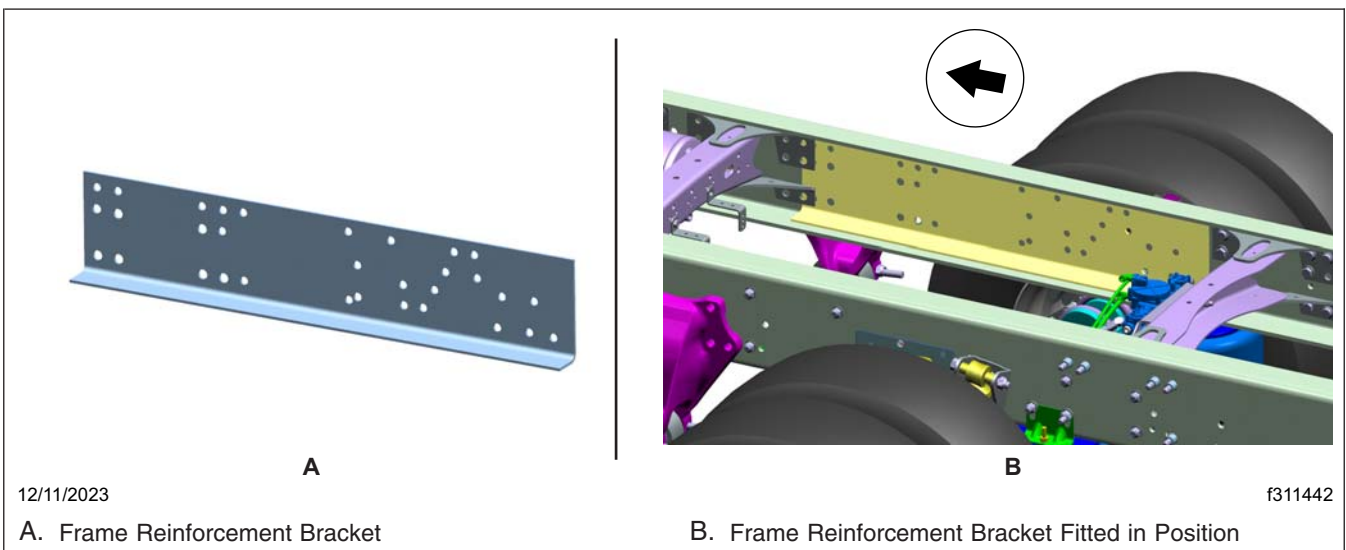
Fig. 9, Installation of the Frame Reinforcement Bracket

In certain customer applications, the load conditions in combination with the body builder modified frame rails can potentially cause cracks to develop at the rear suspension lateral rod bracket area.

13. Remove the fasteners that attach the rear shock absorber bracket to the frame rail.
14. Drill suitable holes in the frame reinforcement bracket, as shown in **Fig. 9**.
15. Slide the frame reinforcement bracket inside the frame rail lining and align with the pre-drilled holes, as shown in **Fig. 9**.
