**Complaint - Oil Leaks on Double Clutch Transmission (Porsche Doppelkupplung (PDK)):
Observe Specified Procedure (88/20)**

Revision: This bulletin replaces bulletin Group 3 88/20, dated January 29, 2024.

Model Line: **911 Carrera (992)**

Subject: **Double clutch transmission (PDK)**

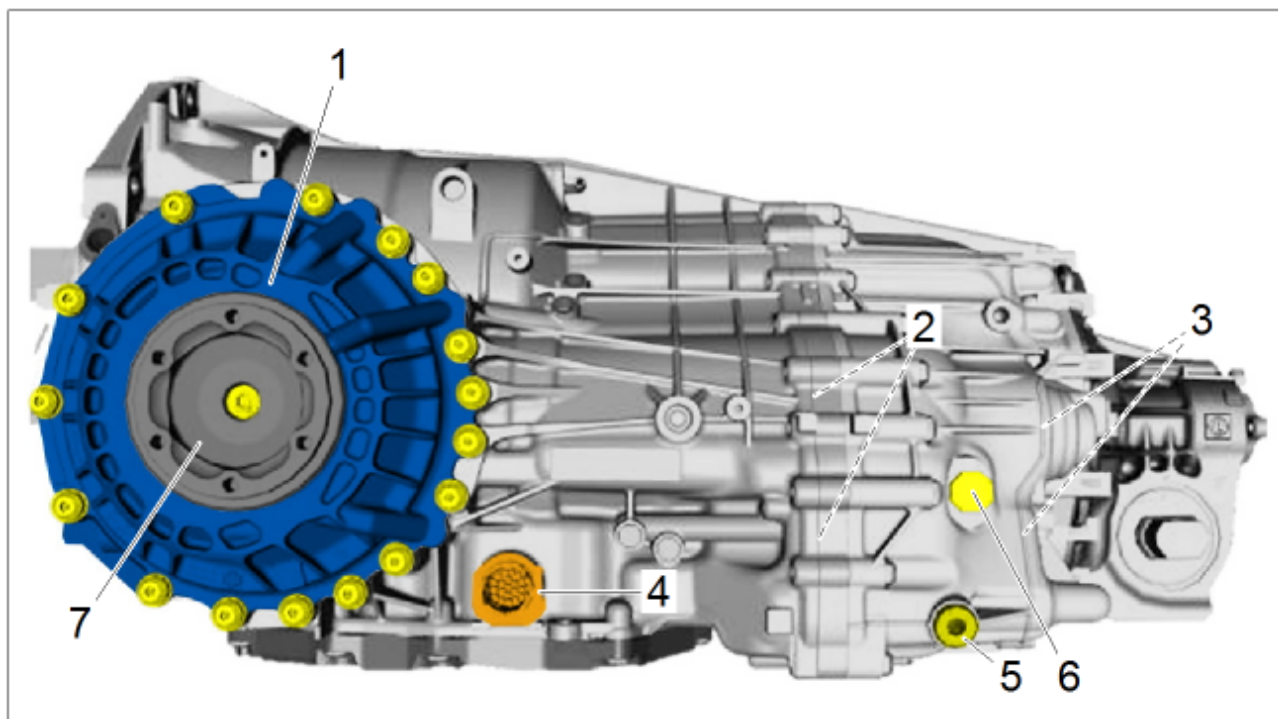
Right side of transmission

Position	Leak area	Possible cause(s)	Repair measure
⇒ Right side of transmission-1-	Differential cover 1A - 1C	Sealing ring damaged (A)	Replace sealing ring, see ⇒ Workshop Manual '391555 Replacing flanged-shaft sealing ring'.
		Screw loose (B)	Replace screws, see ⇒ Workshop Manual '391555 Replacing flanged-shaft sealing ring'.
		O-ring damaged (C)	Replace O-ring, see ⇒ Workshop Manual '391555 Replacing flanged-shaft sealing ring'.
⇒ Right side of transmission-2-	Rear transmission housing seal 2A - 2B	Screw loose (A)	Replace double clutch transmission, see ⇒ Workshop Manual '373419 Removing and installing double clutch transmission'.
		Seal damaged (B)

⇒ Right side of transmission-3-	Front transmission housing seal 3A - 3B	Screw loose (A)	Replace double clutch transmission, see ⇒ Workshop Manual '373419 Removing and installing double clutch transmission'.
		Seal damaged (B)	
⇒ Right side of transmission-4-	Central connector at the left 4A - 4B	Sealing ring damaged (A)	Replace wire harness, see ⇒ Workshop Manual '387719 Removing and installing transmission control mechanism'. Tighten screws to 3 Nm (2 ftlb.).
		Connector leaking (B)	
⇒ Right side of transmission-5-	Screw plug	Sealing ring damaged	Replace screw and tighten to 27 Nm (20 ftlb.). Re-use spring and sleeve during installation.
⇒ Right side of transmission-6-	Oil filler screw	Sealing ring damaged	Replace screw and tighten to 27 Nm (20 ftlb.).
⇒ Right side of transmission-7-	Right halfshaft flange 7A - 7C	Sealing ring damaged (A)	Replace sealing ring, see ⇒ Workshop Manual '392255 Workshop Manual '392255 Replacing sealing ring for right halfshaft flange - double clutch transmission'.

Right halfshaft flange damaged (B)	Replace halfshaft flange, see ⇒ Workshop Manual '392519 Workshop Manual '392519 Removing and installing right halfshaft flange - double clutch transmission'.
		Screw loose, leaking (C)	Replace screw, see ⇒ Workshop Manual '392519 Workshop Manual '392519 Removing and installing right halfshaft flange - double clutch transmission'.

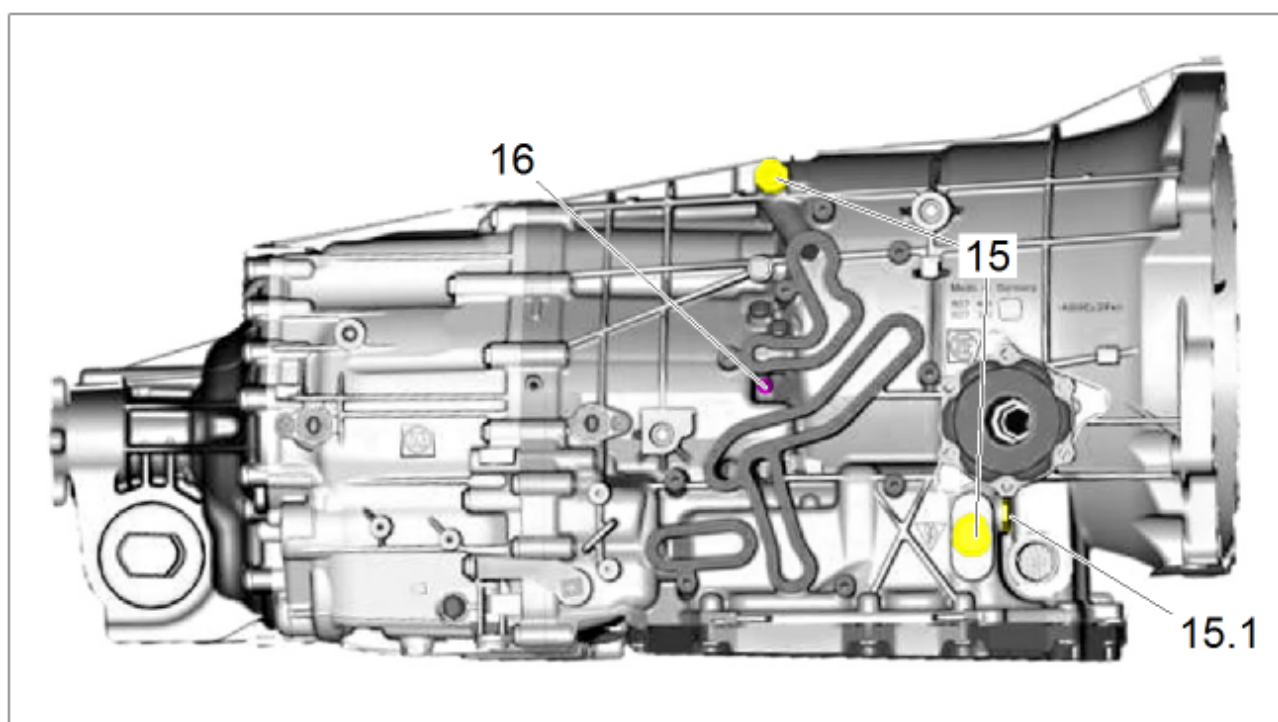
Position	Oil leak	Cause	Repair measure
⇒ Left side of transmission (without ATF cooler) -15-	Screw plug 15A - 15B	Screw loose (A)	Replace screw and tighten to 27 Nm (20 ftlb.).
		Sealing ring damaged (B)	
	Oil filler screw 15C - 15D	Screw loose (C)	Replace screw, see ⇒ Workshop Manual '370235 Checking and topping up ATF'.
		Sealing ring damaged (D)

⇒ <i>Left side of transmission (without ATF cooler) -15.1-</i>	Screw plug 15.1A - 15.1B	Screw loose (A)	Replace screw and tighten to 27 Nm (20 ftlb.).
		Sealing ring damaged (B)	
⇒ <i>Left side of transmission (without ATF cooler) -16-</i>	Oil chamber partition If there are oil leaks in this area, see also ⇒ <i>Left side of transmission (with ATF cooler) -8-</i> and ⇒ <i>Left side of transmission (without ATF cooler) -15 / 15.1-</i> .	Shaft sealing ring damaged	Check the area using an endoscope. Replace double clutch transmission if there are leaks, see ⇒ <i>Workshop Manual '373419 Removing and installing double clutch transmission'</i> .

If there is a leak around item 16, observe the specified procedure.

- Clean oil leak bore area and coat it directly with leak-locating spray
- Correct the oil level
- Perform a test drive
- Visually inspect the leak area of the oil leak bore

If the fault can be reproduced, the double clutch transmission must be replaced. If not, continue fault finding.
