SS 3140 - FTL New Cascadia and M2 PLUS/SD PLUS - "Transmission Service Soon" notification screen

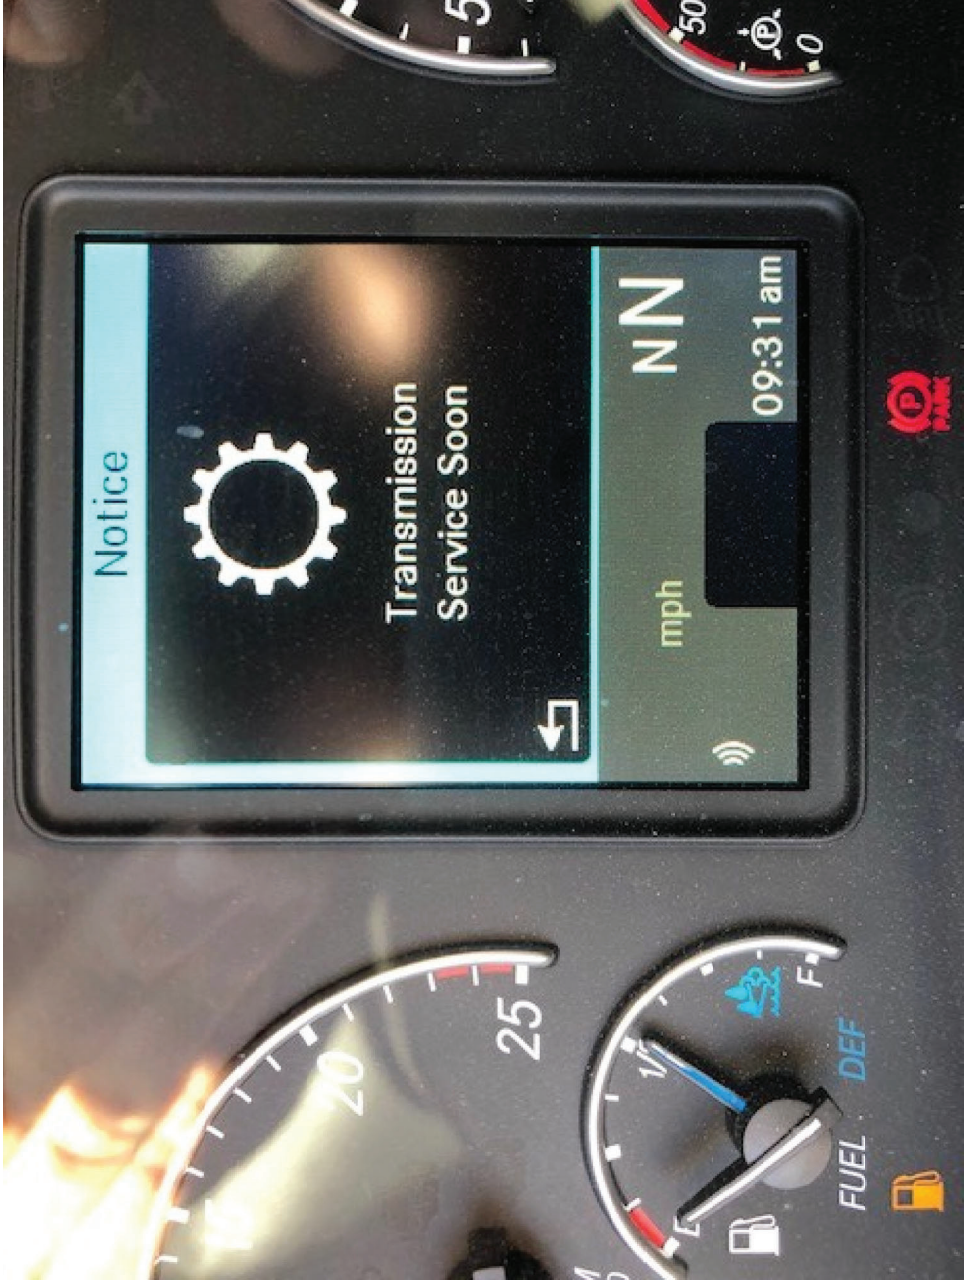
At engine start, a blue-bordered screen with the message "Transmission Service Soon" comes up in the instrument cluster for a couple of seconds, and then disappears. A picture of the screen is attached.

The Transmission Service Soon notification screen displays in the cluster at engine start because Allison Transmission performs a bulb check if the Prognostics feature is enabled in the transmission calibration. On a truck equipped with an Allison pushbutton shifter, the message in the cluster display will be accompanied by the Transmission Service lamp (wrench icon) turning on in the pushbutton shifter display.

When displayed only at engine start as a bulb check, the Transmission Service Soon notification screen *does not* indicate that there is a need to service the transmission. Drivers, owners, and dealer technicians have expressed concern that the screen is being displayed.

It is possible to eliminate the bulb check by disabling Prognostics using Allison Doc software. Allison Transmission indicates that Prognostics can be disabled without affecting operation of the transmission.

If Prognostics is disabled, the Transmission Service Soon notification screen will *only* be displayed when requested by the transmission controls when maintenance is needed.
