Technical product information

Topic	V8 Kovomo - Engine MIL light on - DTC 'P04F000: EVAP system high pressure purge line performance' evident
Market area	Australia E04 Bentley rest Asia and Australia (6E04),China 723 Volkswagen (Anhui) Automotive CO (6723),China 796 VW Import Comp. Ltd (Vico), Beijing (6796),Germany E02 Bentley rest Europe (6E02),Japan E03 Bentley Japan (6E03),Korea, (South) E08 Bentley South Korea (6E08),United Arab Emirates E06 Bentley Middle East and Africa (6E06),United Kingdom E01 Bentley UK (6E01),United States E05 Bentley USA and rest America (6E05)
Brand	Bentley
Transaction No.	2065148/4
Level	EH
Status	Approval
Release date

V8 Kovomo

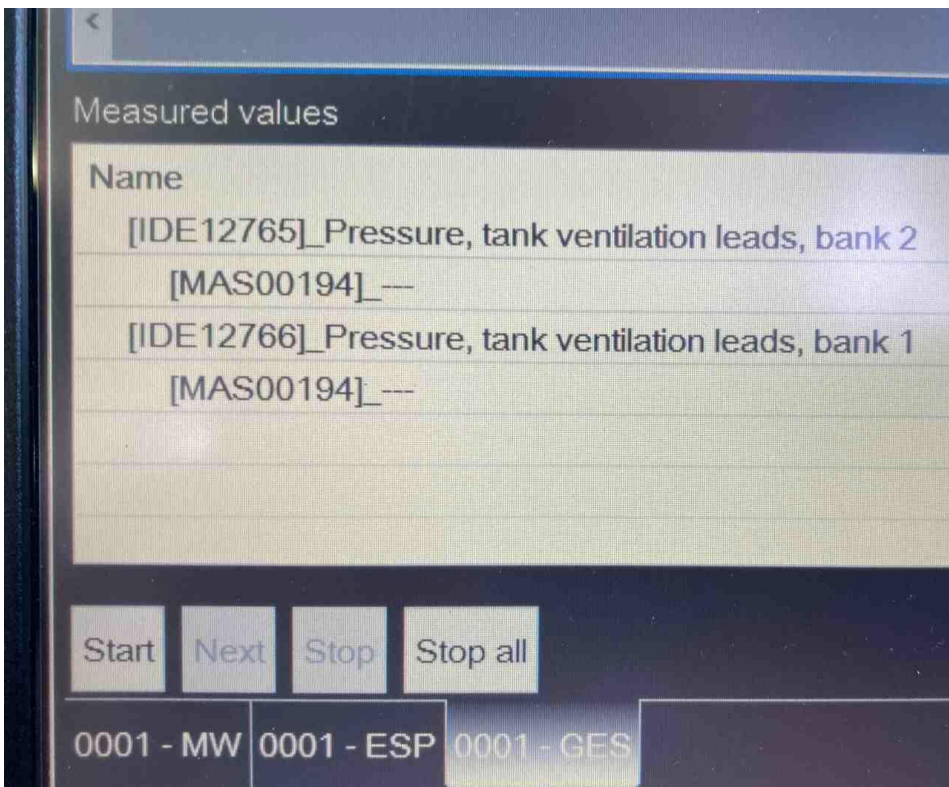
Figure 1

Observations when monitoring IDE12765 and IDE12766

Referring to Figure 1:

IDE12765 (When monitored) fluctuates from the static value found (Ignition on/Engine Off)

With/without purge activation

IDE12766 (When monitored) **DOES NOT** fluctuate from the static value found (Ignition on/Engine Off)

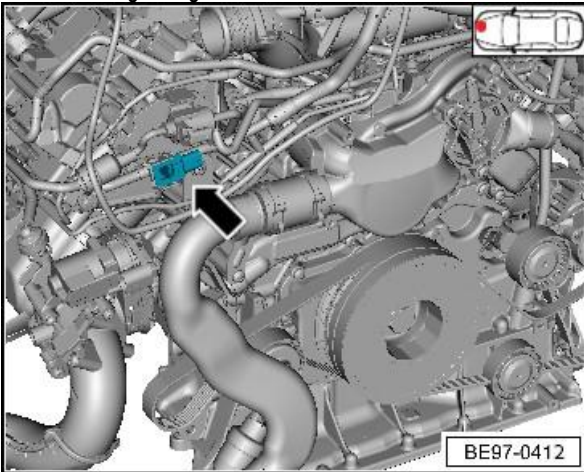
- Referring to Figure 2 - Locate the Pressure sensor connector (T3dd) for the activated charcoal filter system (G804)

- Disconnect T3dd
- Disconnect T56aj from the Engine control unit (J623)
- Referring to the applicable wiring diagram within in Elsa pro - Conduct a wiring integrity check

From T3dd (PIN's 1 and 2) - To Connector T56aj (PIN's 1 and 5)

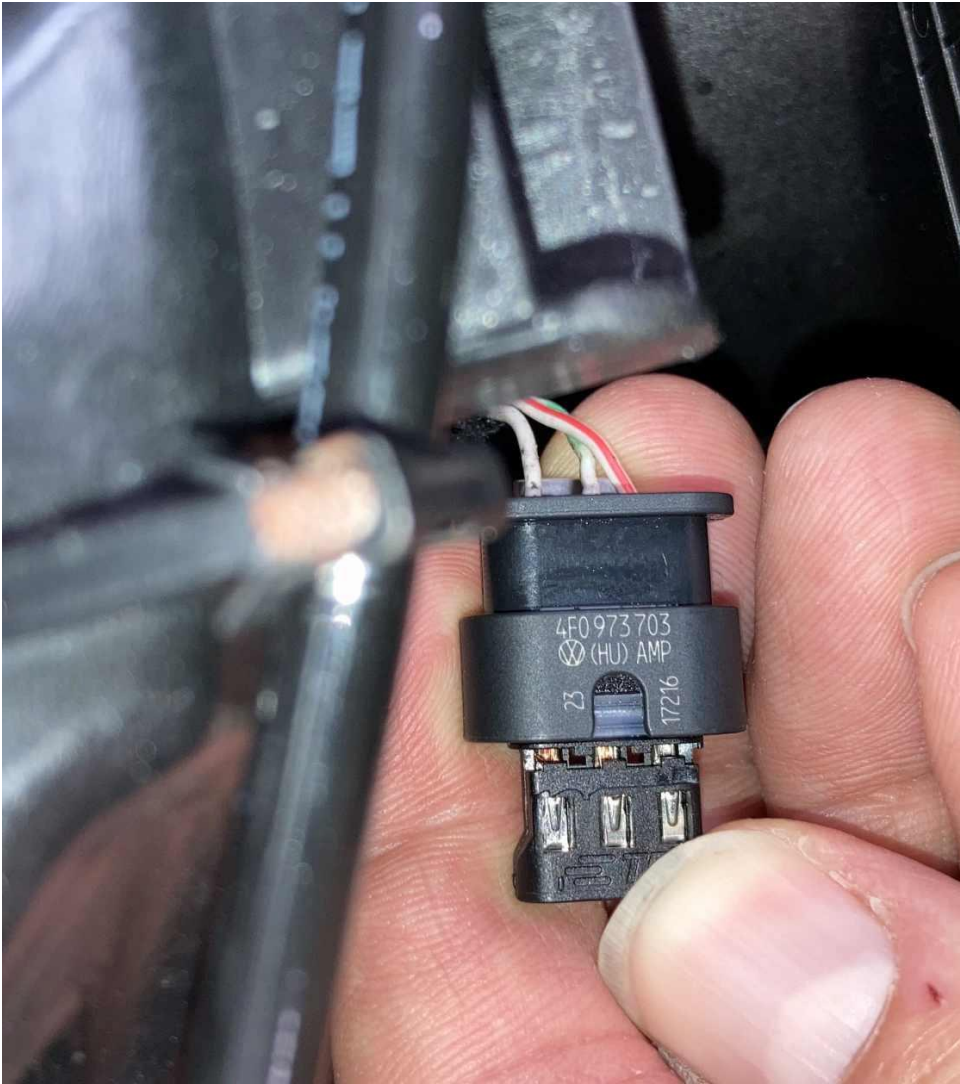
2) Referring to Figure 3 and the attached PDF instructions - De-pin/Remove PIN's 1 and 2 from connector T3dd

TIP: As both wires are white, the green line which can be seen on the central white wire was applied to aid the operative when swapping the PIN's to the correct locations

3) Install PIN 2 into PIN 1

4) Install PIN 1 into PIN 2

5) Conduct a wiring integrity check from T3dd (PIN's 1 and 2) - To Connector T56aj (PIN's 1 and 5)
