Technical product information

Topic	Engine overheating - Warning on the DIP - V8 Kovomo
Market area	Australia E04 Bentley rest Asia and Australia (6E04),China 723 Volkswagen (Anhui) Automotive CO (6723),China 796 VW Import Comp. Ltd (Vico), Beijing (6796),Germany E02 Bentley rest Europe (6E02),Japan E03 Bentley Japan (6E03),Korea, (South) E08 Bentley South Korea (6E08),United Arab Emirates E06 Bentley Middle East and Africa (6E06),United Kingdom E01 Bentley UK (6E01),United States E05 Bentley USA and rest America (6E05)
Brand	Bentley
Transaction No.	2061369/6
Level	EH
Status	Approval
Release date

Bentayga-New Continental GT/C-New Flying Spur (V8 Kovomo)

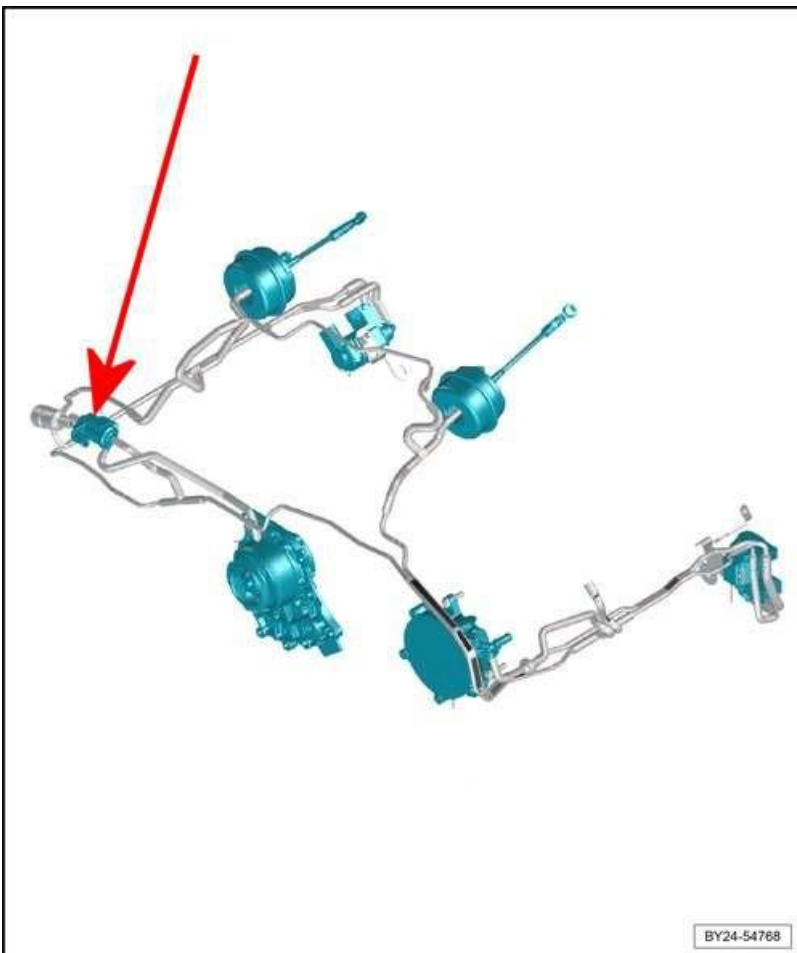
Figure 1 Shows Bentayga (Arrow)

IMPORTANT: The switch valve for mechanical coolant pump N649 fails due to an internal leak from coolant pump causing corrosion within the unit from coolant migration

1) Referring to Figures 1,2 and 3 - With care (visually monitor for any traces of coolant) disconnect each vacuum hose from the switch valve for mechanical coolant pump N649

2) Referring to Rep.Gr 19 - Replace all of the following parts

- Coolant pump
- Coolant regulator (Thermostat)
- Switch valve for mechanical coolant pump N649

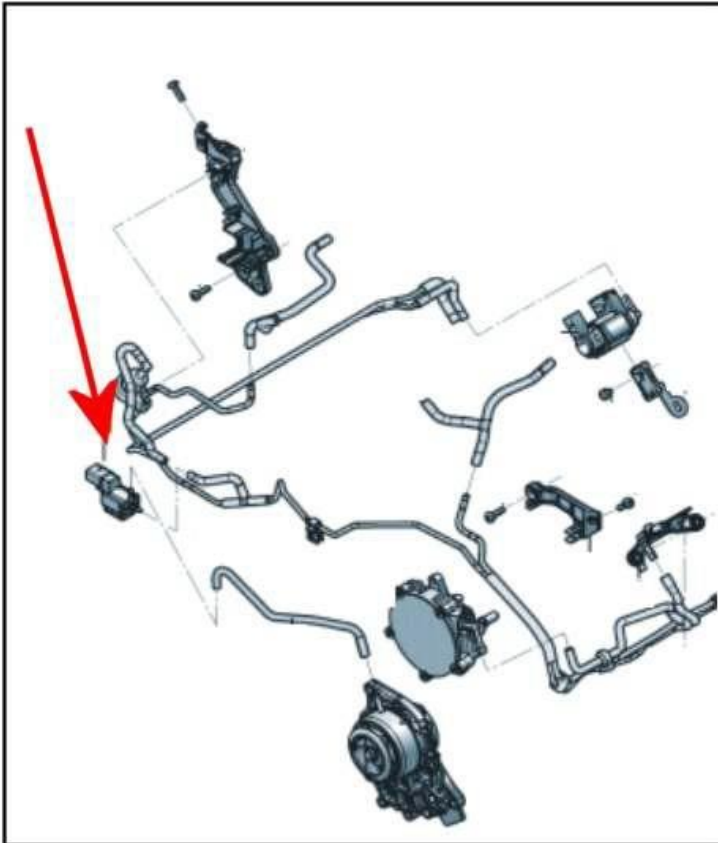
Figure 2 Shows New Continental GT/ GTC and Flying Spur (Arrow)

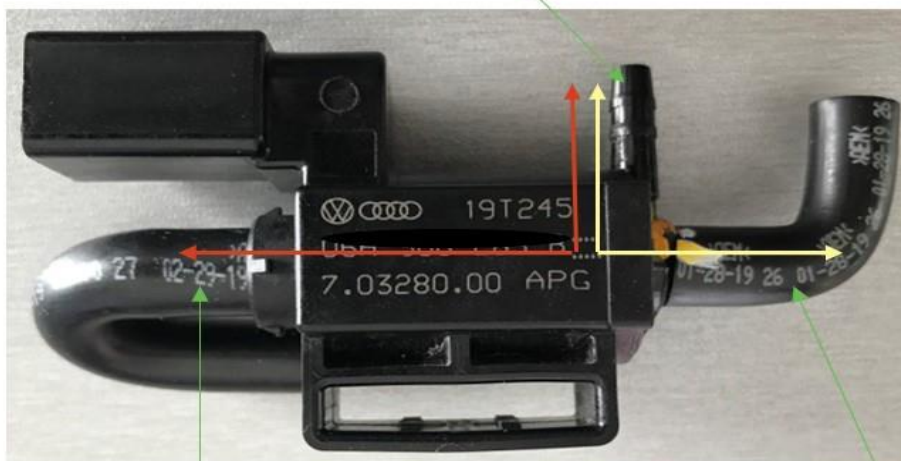
TIP: When the switch valve for mechanical coolant pump N649 is at fault (sticking open) the vacuum supply is constant, this allows the sleeve to stay in position around the impellor which leads to the symptoms described within the Customer statement/Workshop findings section of this TPI

- Referring to Figure 3 the standard operation of N649 (with no operational issues) is as follows:
- Un-energised state (Ignition off) = coolant pump connected to vent connection (red arrows)
- Energised state (Ignition on) = engine vacuum connection to coolant pump (yellow arrows)
