WRB6 - Replacing Gateway Control Unit (Stop Delivery)

Model Line: **Taycan (Y1A / Y1B / Y1C)**

Concerns: **Gateway control unit**

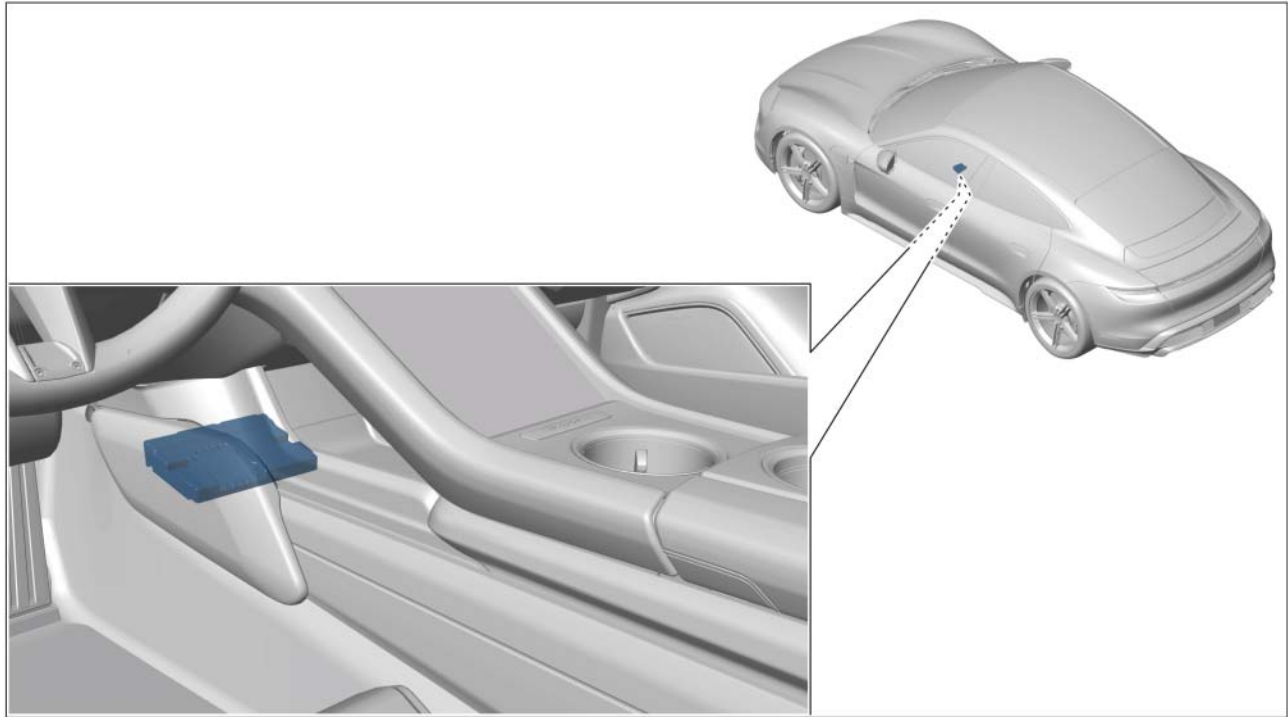
Installation position of gateway control unit
