**Ignition Lock Error B143C29**

Models	Model Year	Model Type	VIN Range	Vehicle-Specific Equipment
911	As of 2020 up to 2024	992	N/A	N/A
Cayenne	As of 2019 up to 2023	9YA, 9YB	N/A	N/A
Panamera	As of 2017 up to 2023	971	N/A	N/A

Revision	Release Date	Changes
0	February 28, 2024	Original document, replaces ATI Group 2 2125.1, dated 01/07/2022.

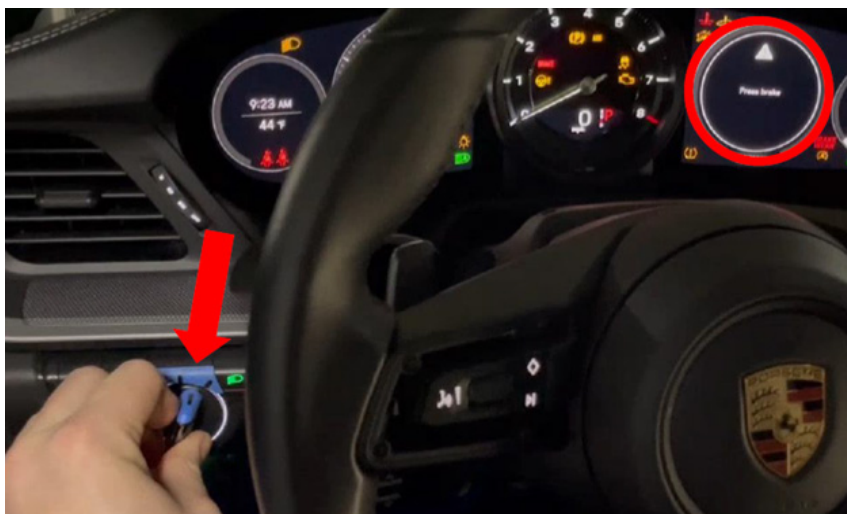
**Figure 1**

If the ignition switch is not fully engaged to start the engine, one of the four signals will not be switched (open line). However, due to the design of the redundant system, the engine will still start. If the diagnostic for this signal continuously sees an open line, the fault will eventually be set in the BCM2.

Please advise the customer to fully engage the ignition switch to start the engine each time to ensure the system functions as designed and a real fault can be diagnosed. The image below shows a partial switch engagement, which will lead to this fault after enough occurrences. Since this is a redundant system, the engine will start and there will be no warning that it is being misused until the diagnostics eventually sets the fault after the threshold is reached.
