## Technical Service Bulletin

24-BD-001G

PROPER REMOVAL OF WINDSHIELD WIPER BLADE  
PROTECTIVE COVER

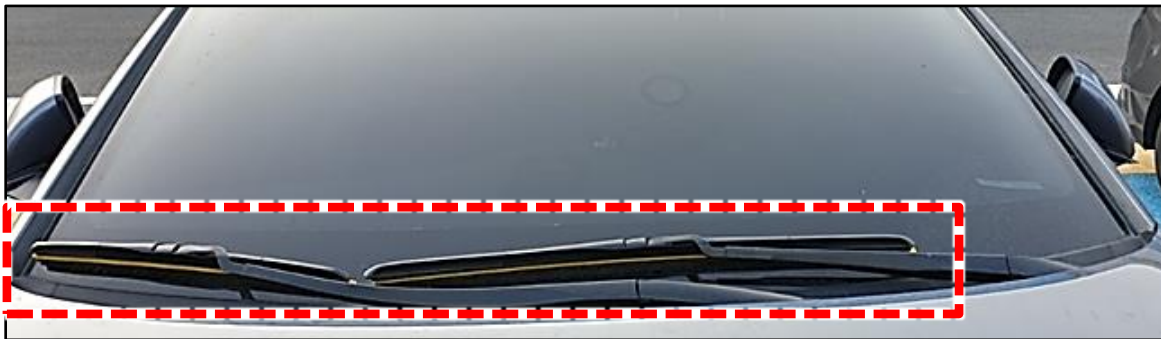
Example of Protective Cover: Passenger Side

Example of Protective Cover: Driver Side

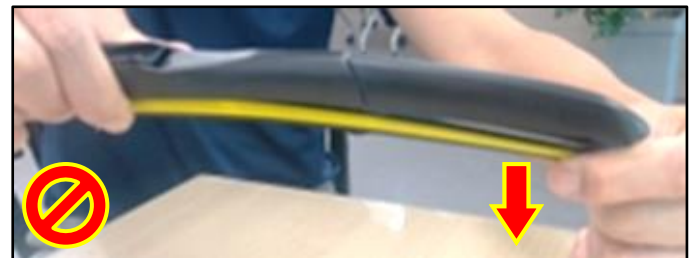
**Incorrect Removal:**

Do not pull down on the protective cover. See examples of incorrect removal results below.

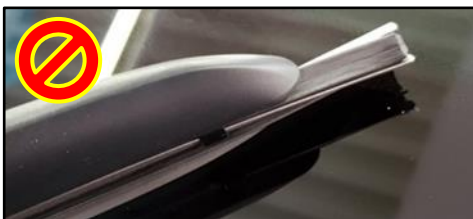
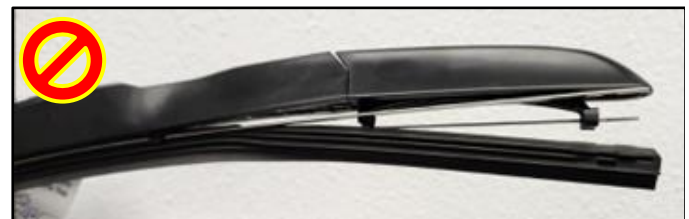
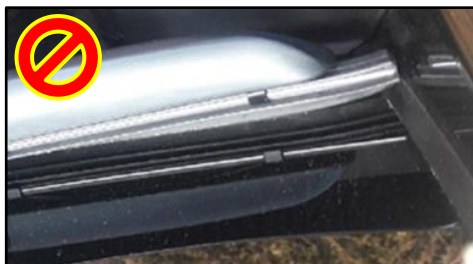
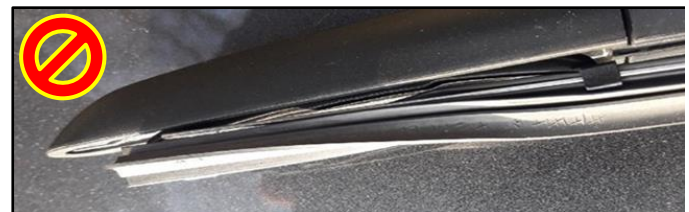
**Examples of incorrect removal results:**

**Description:** This bulletin contains information about the proper removal of the windshield wiper blade protective cover on all models. If the protective cover is not removed correctly, there is a possibility of the rubber insert and rail spring becoming partially separated on the inner side of the wiper blade, which could lead to poor wiping performance and/or possible scratching of the windshield glass. Follow the procedure in this bulletin to properly remove the windshield wiper blade protective cover on all new wiper blades.
