<b>Subject:</b>  NOISE FROM FRONT RIGHT SIDE WHEN DRIVING OVER BUMPY ROADS	<b>Bulletin No.:</b> 09-007/24
	<b>Last Issued :</b> 02/02/2024

2024 CX-90 with VINS lower than JM3KK\*\*\*\*\*153439 (produced before December 13, 2023)

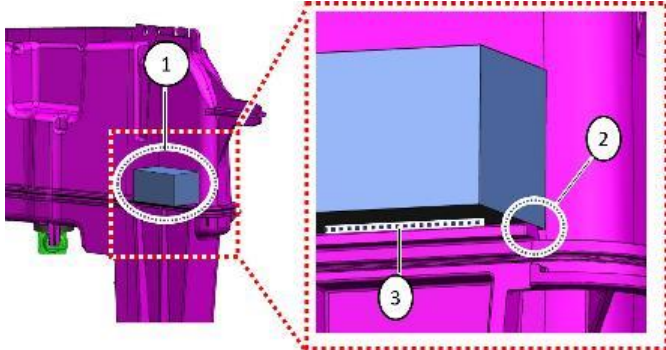
Some customers may complain about an unusual noise (rattling or cracking noise) coming from the front right side of the vehicle when driving over bumpy roads. This may be caused by the washer tank fixing pin (1), which is inserted to the body, and the hole where the pin is inserted colliding with each other when the vehicle is moving over bumps. To eliminate this concern, a new protector is attached to the washer tank.

4. Attach the protector (1) to the washer tank.

- Align the protector edge with the washer tank rib end (2).
- Set the protector so that its side is parallel to the washer tank rib (3).
