Subject: CLICKING NOISE FROM LIFTGATE LATCH AND LOCK ACTUATOR WHEN DRIVING ON BUMPY ROADS	Bulletin No.: 09-012/24
	Last Issued : 02/13/2024

APPLICABLE MODEL(S)/VINS

2024 CX-90 with VINS lower than JM3KK*****152546 (produced before Decemeber 6, 2023)

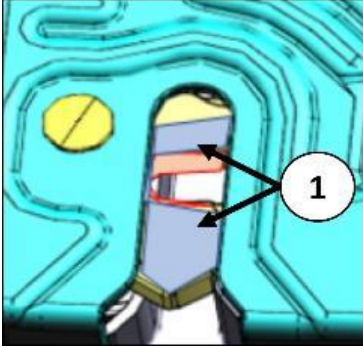
4. Check the latch coating (1), (2).

- **CASE 1:** If coating flaking is observed, replace the lock actuator with a new one referring to the instructions on MGSS (LIFTGATE LATCH AND LOCK ACTUATOR REMOVAL/INSTALLATION), then go to step 8.
- **CASE 2:** If coating flaking is not observed, go to step 5.

5. Spray parts cleaner on a cloth and completely remove the grease and the wear debris from the lock striker's surface and from the lock actuator engaging section (1).
