Service Alert

| Subject: | | |
|---|---|--|
| RATTLE FROM SUNROOF AREA | Service Alert No.: SA-001/24 | |

2023-2024 CX-50

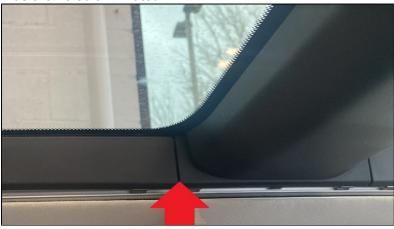
The noise comes from the side cover vibrating against the assembly at the location marked by the arrow due to poor retention of the cover clips.

1. Test drive the vehicle and if you hear the noise, press the edges of the side covers (6 total) as shown in the example below.

4. Replace all 6 link covers and retest for the rattle noise.
