Change to the login procedure for the payment service in the toll system (code 943)

Topic number	LI82.88-P-077552
Version	1
Function group	82.88 - Toll system
Date	2/29/24
Validity	All vehicles with code 943
Reason for change

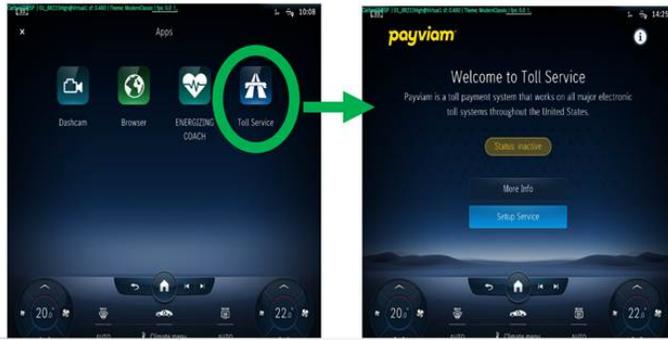
Figure 1

In future, the service activation will instead take place via the website of the Payviam service provider. (Figure 1)

To activate the toll system control unit, a service activation must be implemented by the customer for the payment method (credit card information) to be transmitted to the service provider and their terms and conditions to be accepted. Previously, the activation process took place via the Toll Service app in the head unit.
