# Service Bulletin

Bulletin No.: 19-NA-037

**Subject: No Start, Hard Start with Belt Squeal, Belt Break, Loss of Power Steering and/or Power Brake Assist**

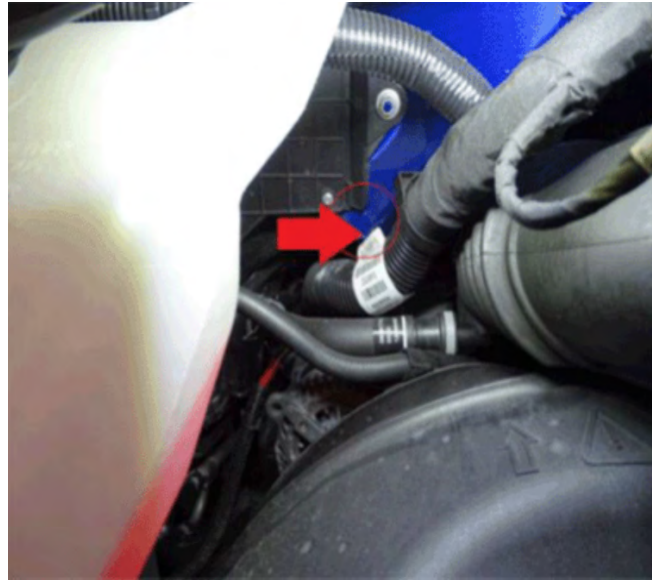
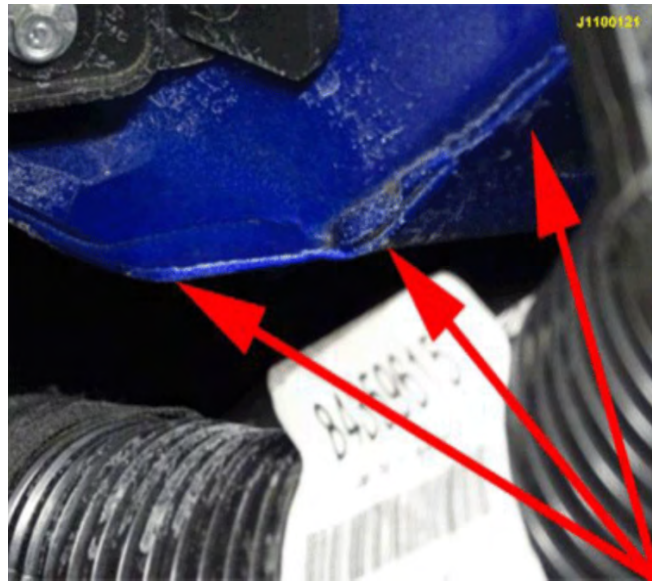
<b>Involved Region or Country</b>	North America, Middle East and Israel.
<b>Condition</b>	Some customers may comment on one or more of the following: <ul style="list-style-type: none"><li>• Vehicle will not start.</li><li>• Vehicle hard to start, with a squeal noise originating from the engine compartment.</li><li>• Vehicles fan belt broken.</li><li>• Loss of power steering</li><li>• Loss of vehicles power brake assist.</li></ul>
<b>Cause</b>	The cause of the condition may be water leaking from the cowl area into the generator vents. Under certain weather conditions, this water can freeze inside and prevent the generator from turning.

**Note:** The common location of the water leak path is shown in the graphics above.

- Seal water leak at cowl with Kent Automotive High-Tech™ Clear Seam Sealer, following the steps in the Service Procedure below.

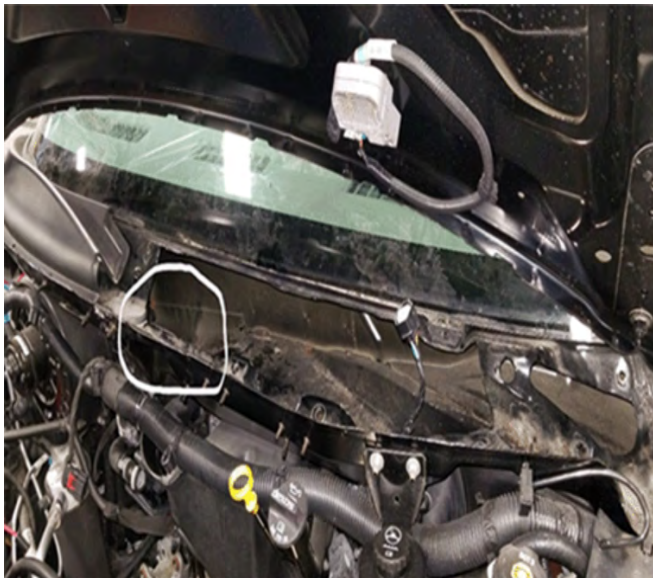
5246055

2. Note the location of the inner lower right side seam circled in the graphic above.
