# Service Bulletin

Bulletin No.: 20-NA-121

**Subject:** Water Leak at Roof Area, Various Electrical Issues, No Start, Stall, Brake Lamp Not Off, Radio Inoperative, Remote Key Inoperative, TPM Light Illuminated, Malfunction Indicator Lamp (MIL) Illuminated with Possible DTCs C0750 SYM29, C0755 SYM29, C0760 SYM29, C0765 SYM29

Brand:	Model:	Model Year:		VIN:		Engine:	Transmission:
		from	to	from	to		
Buick	Encore GX	2020	2024	—	—	All	All
Chevrolet	Trailblazer (VIN M)	2021	2024	—	—	All	All

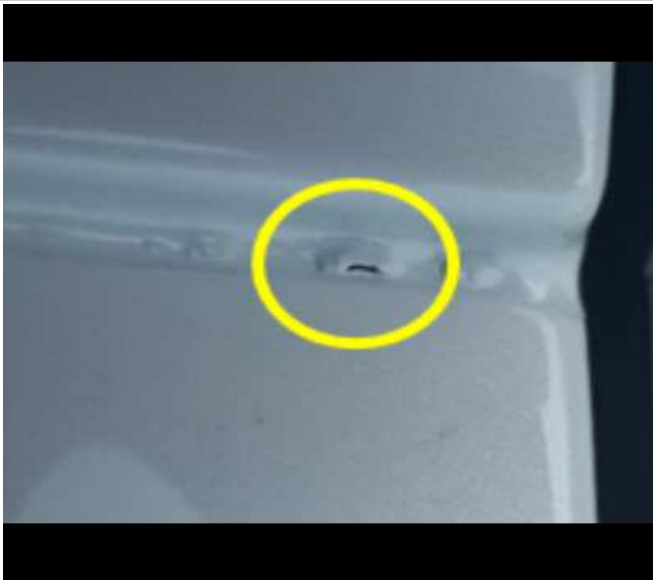
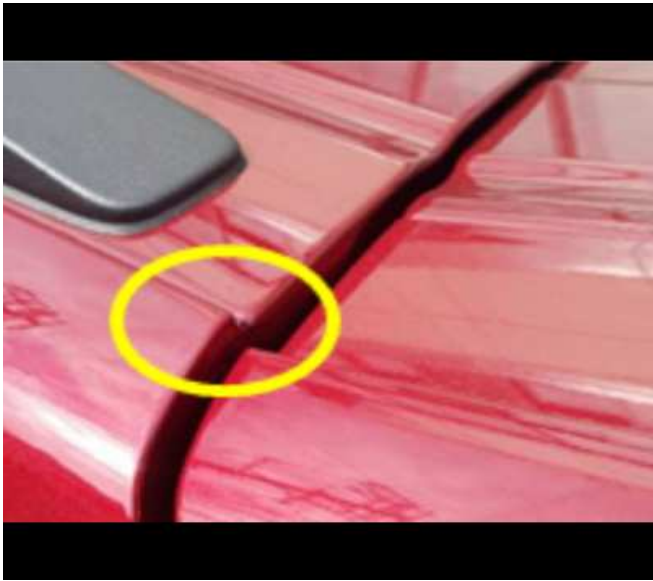
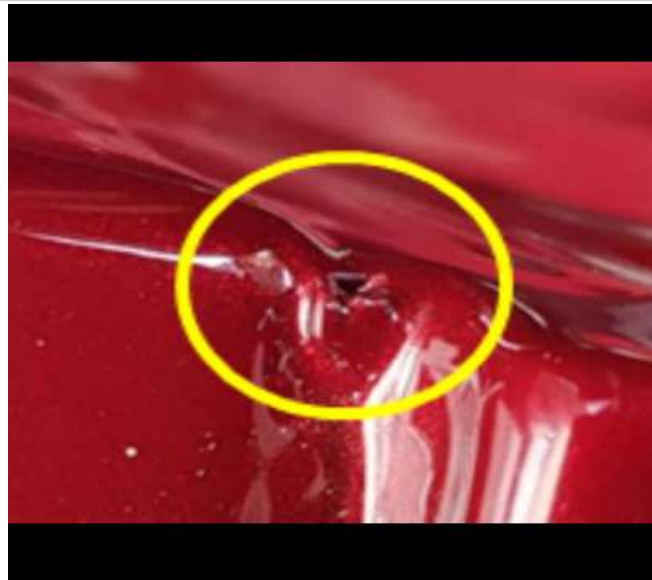
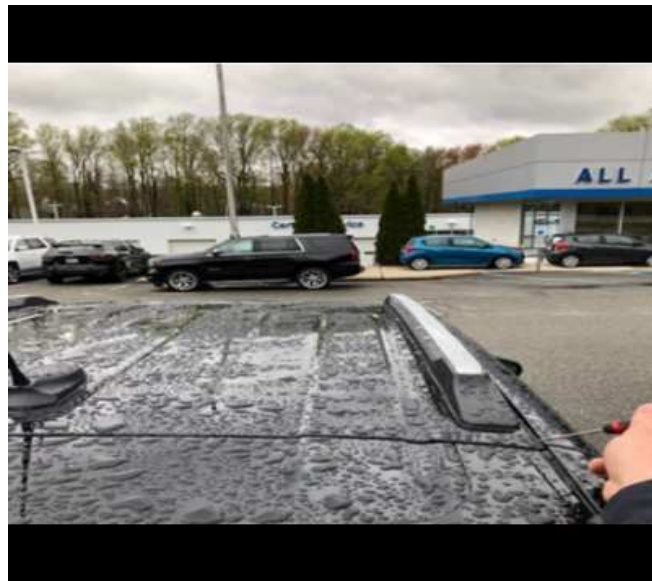
The cause of the condition may be a pin hole in the roof body seam welding/sealing.

Inspect for a leak and repair as necessary.

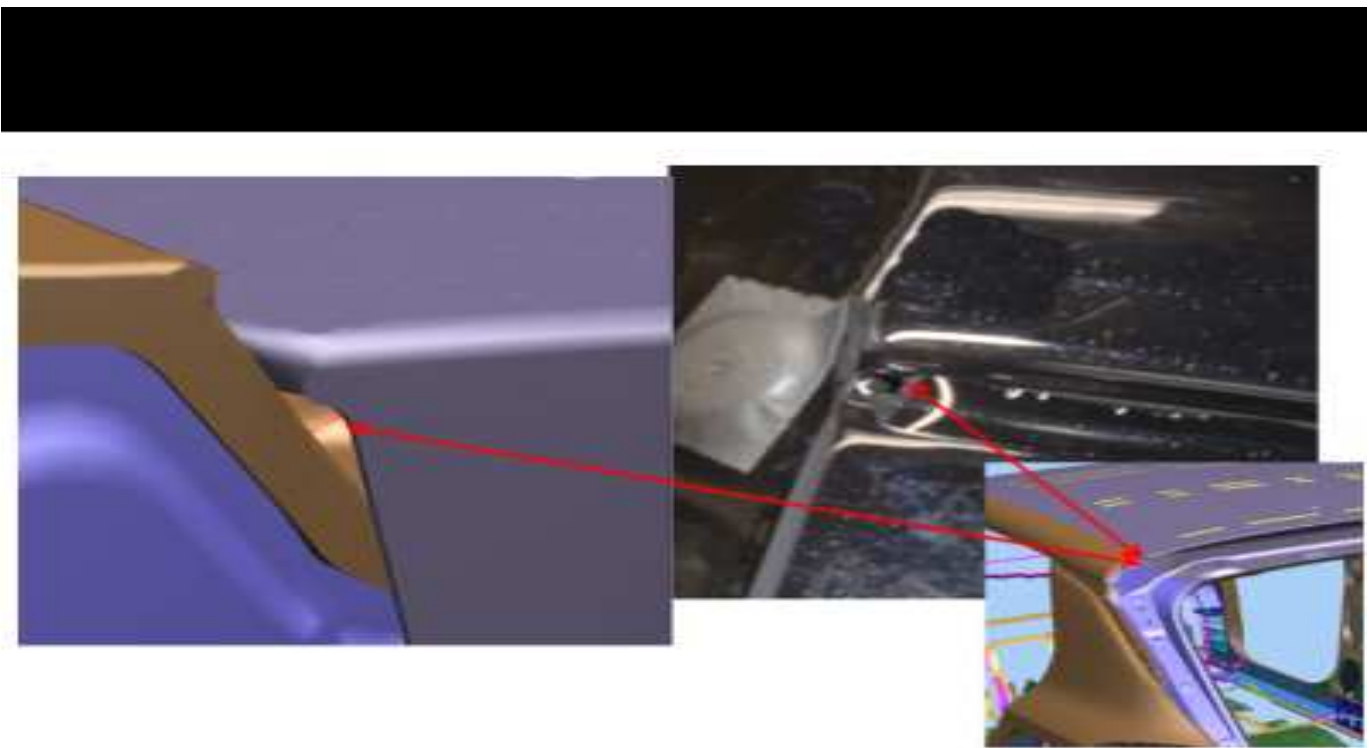
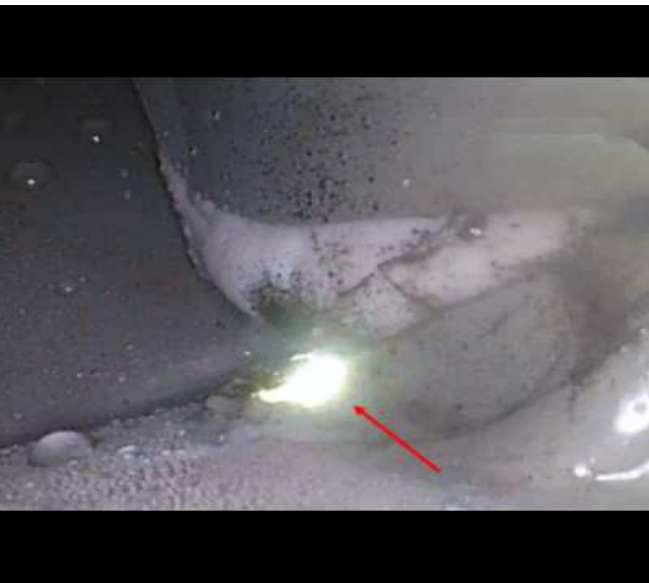
5912862

**Note:** Water leaks in the rear of vehicle were root caused to one large leak at driver side, rear upper liftgate area. The math file below shows the location of the leak, and the photo shows a view from the underside of the roof.

Once the damage is repaired, apply seam sealer along the roof to body seam to correct the condition.

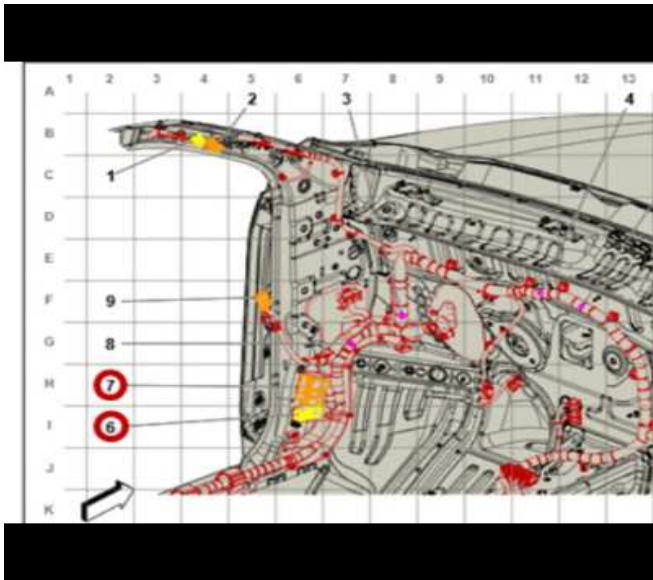
5703541

**(#8) — X204 Instrument Panel Harness to Body Harness, 76-way connector right side**

**(#6) — X202 Instrument Panel Harness to Body Harness, 2-way connector left side**

**(#7) — X200 Instrument Panel Harness to Body Harness, 76-way connector left side**

Clean the water inside of the connector and apply NYOGEL on terminals for waterproofing.

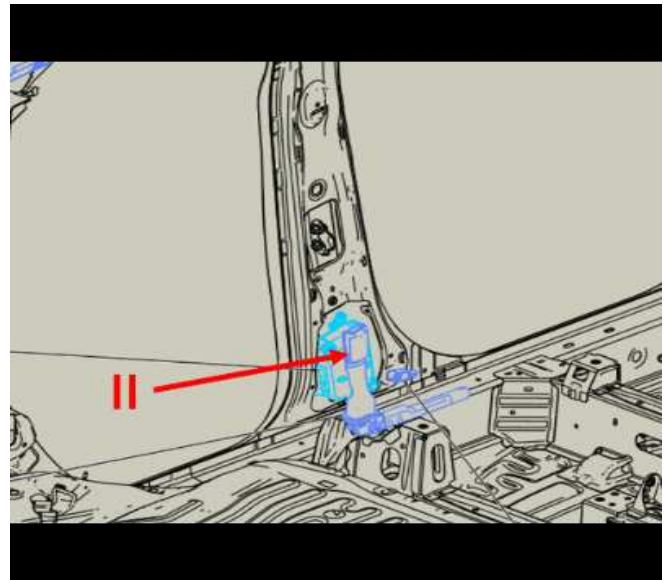
5752327

**(#11) — F112D Seat Belt Retractor Pretensioner - Driver**

**(#4) — F112P Seat Belt Retractor Pretensioner – Passenger (not shown)**
