Service Bulletin

Bulletin No.: 22-NA-182

Subject: Information on 6L80 6L90 8L90 10L80 10L90 10L1000 Equipped Vehicles With A Harsh Shift, Shudder, Surge, Stall, Neutral/Flare, Transmission Overheating and/or High Transmission Fluid Temperature

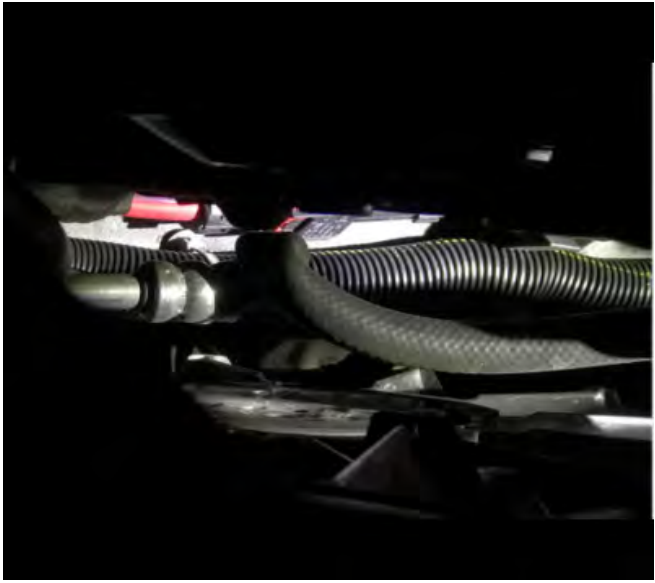
<p style="text-align: right;">5758376</p> <p>Inspect for a twisted cooler line, example shown in the graphic above.</p> <p>In some cases, it may be necessary to remove the under-body panels in order to clearly see the cooler lines.</p> <ul style="list-style-type: none"> • If the cooler line is twisted, disconnect the cooler line from the transmission auxiliary cooler and untwist it, then reconnect the cooler line. • If the cooler line remains misshaped after untwisting, the cooler line should be replaced then check the transmission fluid level following SI. Add fluid if needed. • If no concerns are found with the rubber line being misshaped, check the transmission fluid level following SI. Add fluid if needed. <p>The Thermal Bypass Valve (TBV) may be the cause of the overheat if a cooler line is not twisted or misshaped. The TBV will open at the following temperatures for the models listed in this TSB:</p> <ul style="list-style-type: none"> • 6 Speed (6L80, 6L90) - 158F (70C) - TBV is external to the transmission. • 8 Speed (8L90) - 194F (90C) – TBV is external to the transmission. • 10 Speed (10L80, 10L90, 10L1000) – 143F (61C) – TBV is within the valve body on all listed applications except those equipped with 3.0 (LM2) (LZ0) Diesel. The (LM2) and (LZ0) Diesel, the TBV is on the frame rail, external to the transmission and opens at 194F (90C).
