Subject: DTC U3000 Setting in Automated Map Module (HDLM) - SuperCruise Unavailable

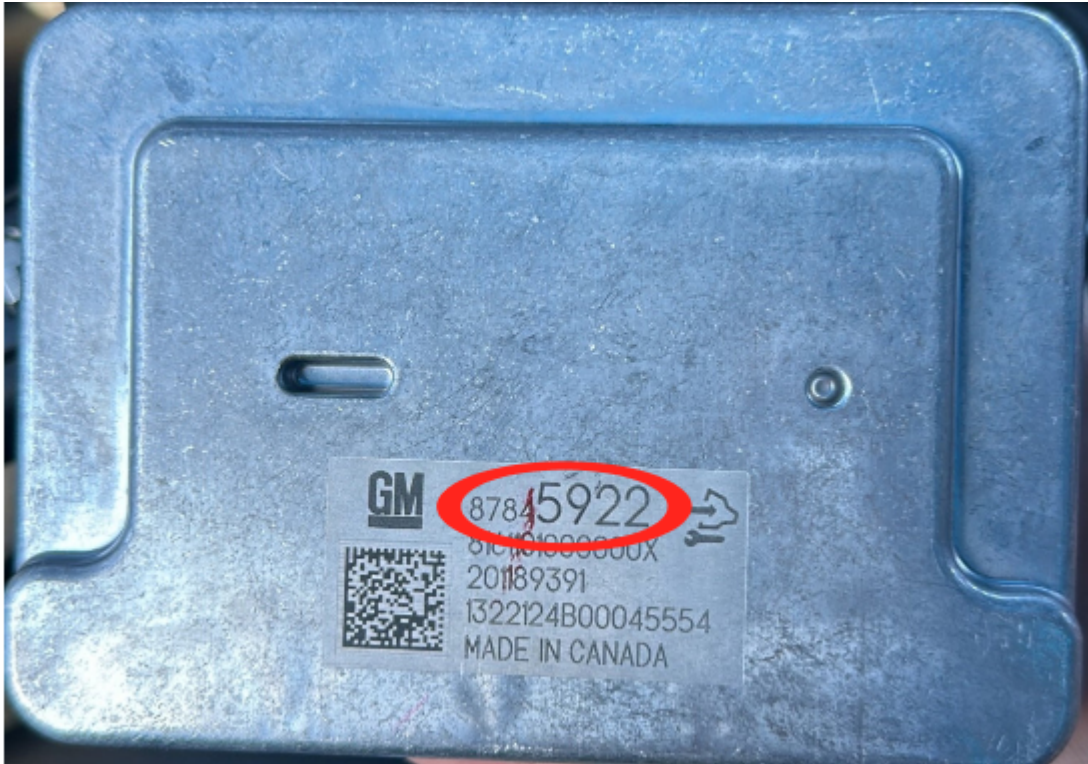
6553204

| Condi- tion | Some customers may comment that when trying to engage SuperCruise, the cluster will display the message “SuperCruise un- available – No road info”. Technician will find DTC U3000 setting in the module. |
| Cause | The cause of the condition may be due to a reset condition in the module causing the message to display and the U3000 DTC to set in the HDLM. |

| Cor- rec- tion | Technicians are asked to verify the condition by driving on 2 different verified SuperCruise roads. Replace the HDLM module if, and only if, the part number of the HDLM in the vehicle is listed in Parts Information. Important: Please refer to the Electronic Parts Catalog (EPC) to order the latest release part number for this module. |

If one of these Map module part numbers listed in Parts Information is not installed in the vehicle, and the map module is setting the U3000 DTC with SuperCruise being unavailable, do not replace the module until additional diagnostics through SI are completed.
