# Service Bulletin

Bulletin No.: 23-NA-008

**Subject: DEF Pump Controller Update with DTCs P105A and/or P208A Set.**

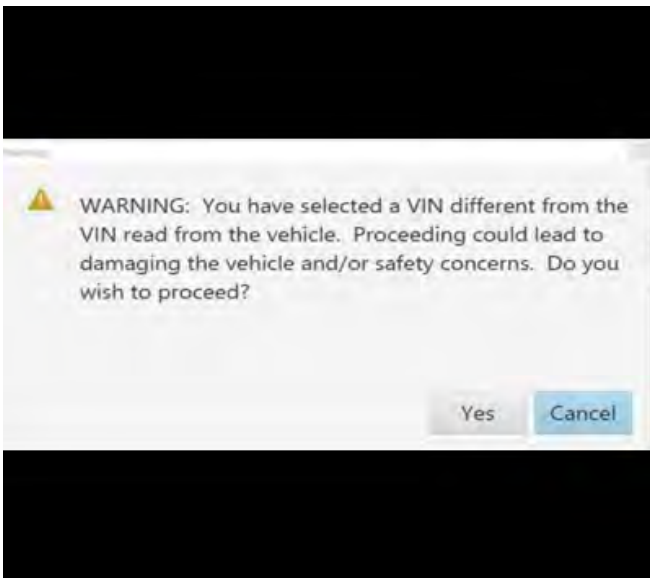
5877000

**Important:** If the vehicle VIN DOES NOT match, the message below will be shown

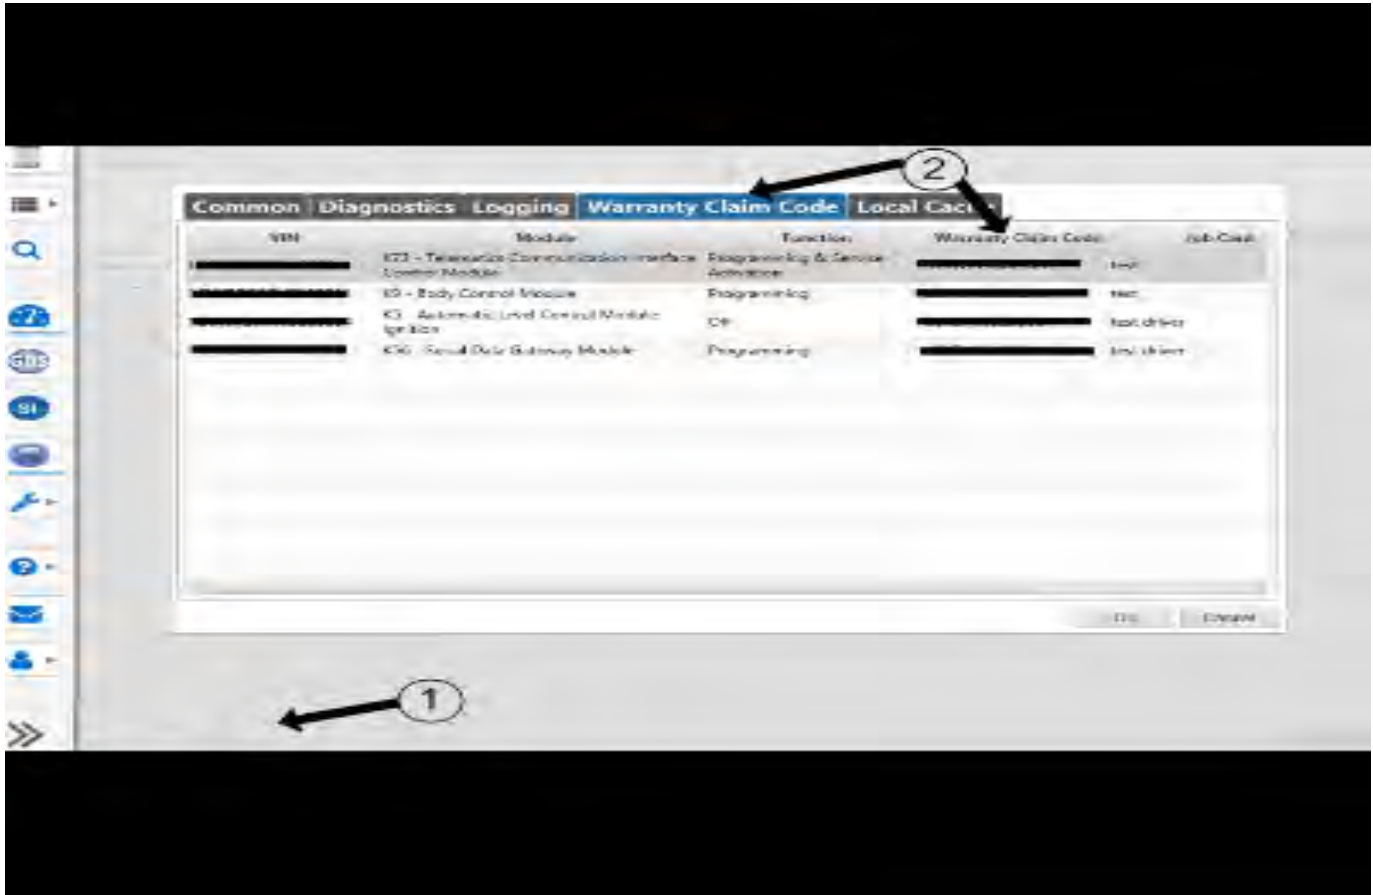
6125774

If the Warranty Claim Code was not recorded on the Job Card, the code can be retrieved in the SPS2 system as follows:

1. Open TLC on the computer used to program the vehicle.
2. Select and start SPS2.
3. Select Settings (1).
4. Select the Warranty Claim Code tab (2).
