Technical product information

Topic	Squeaking noise from the footwell whilst steering / manoeuvring at low speed
Market area	Australia E04 Bentley rest Asia and Australia (6E04),China 796 VW Import Comp. Ltd (Vico), Beijing (6796),Germany E02 Bentley rest Europe (6E02),Japan E03 Bentley Japan (6E03),Korea, (South) E08 Bentley South Korea (6E08),United Arab Emirates E06 Bentley Middle East and Africa (6E06),United Kingdom E01 Bentley UK (6E01),United States E05 Bentley USA and rest America (6E05)
Brand	Bentley
Transaction No.	2073002/1
Level	EH
Status	Approval
Release date

Bentayga Series

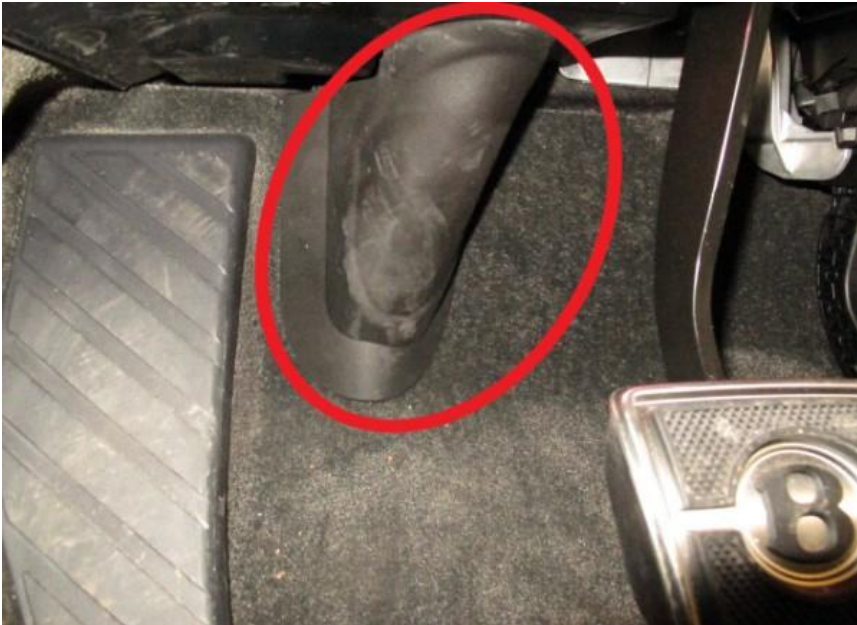
Figure 1

Squeaking noises from the foot well (Figure 1) with whilst steering / manoeuvring at low speed

- Noise is apparent with steering input whilst steering / manoeuvring at low speed
- Noise is evident from the rubber collar on the lower steering column
- Noise is apparent when the steering wheel is adjusted to the fully upwards position

- The rubber collar which is fitted to the intermediate steering shaft in some cases can contact the sealing boot
