SERVICE BULLETIN

Communication #: I-24-01

Model Year(s): 2022

SUBJECT: HEAVYWEIGHT LIQUID COOLED CAVITY PLUG

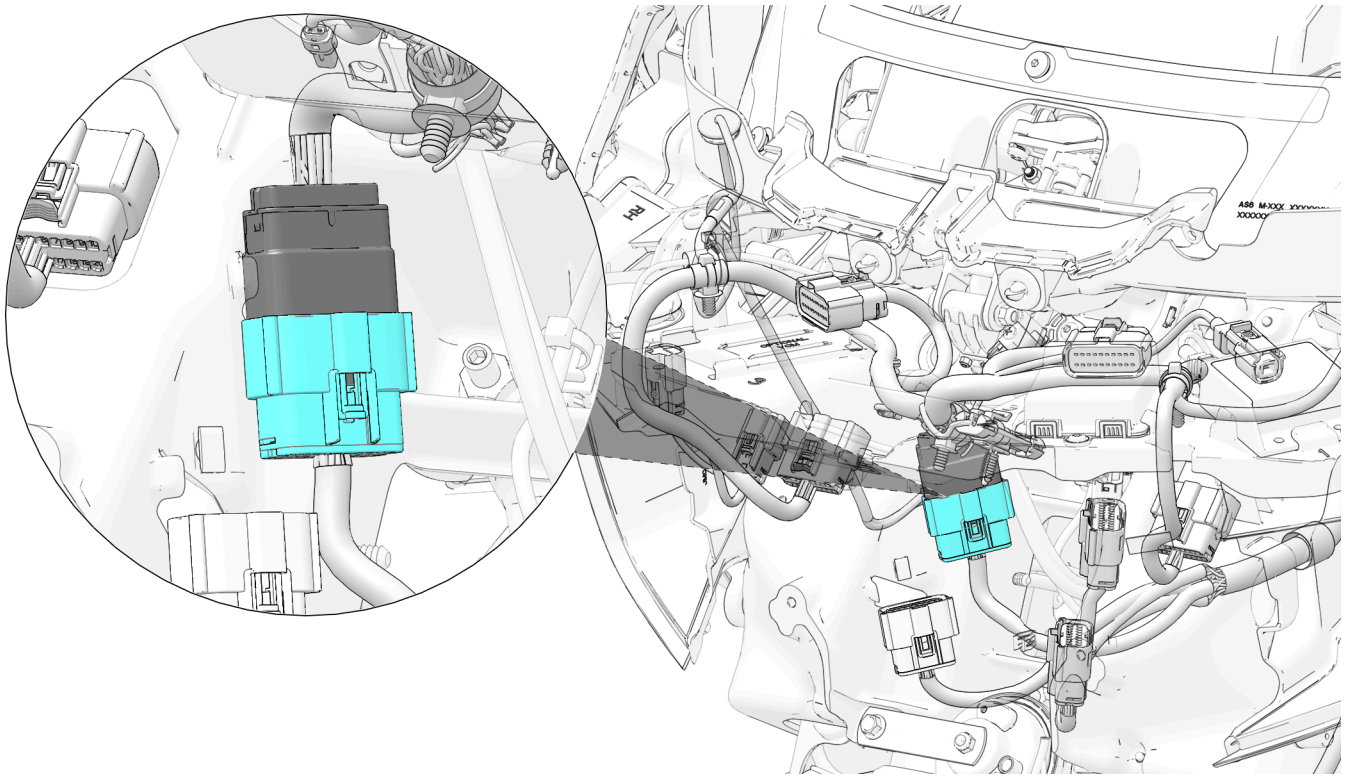
1. Disconnect the 20-pin chassis harness to fairing harness connector located on the left-hand side of the fairing as shown below.

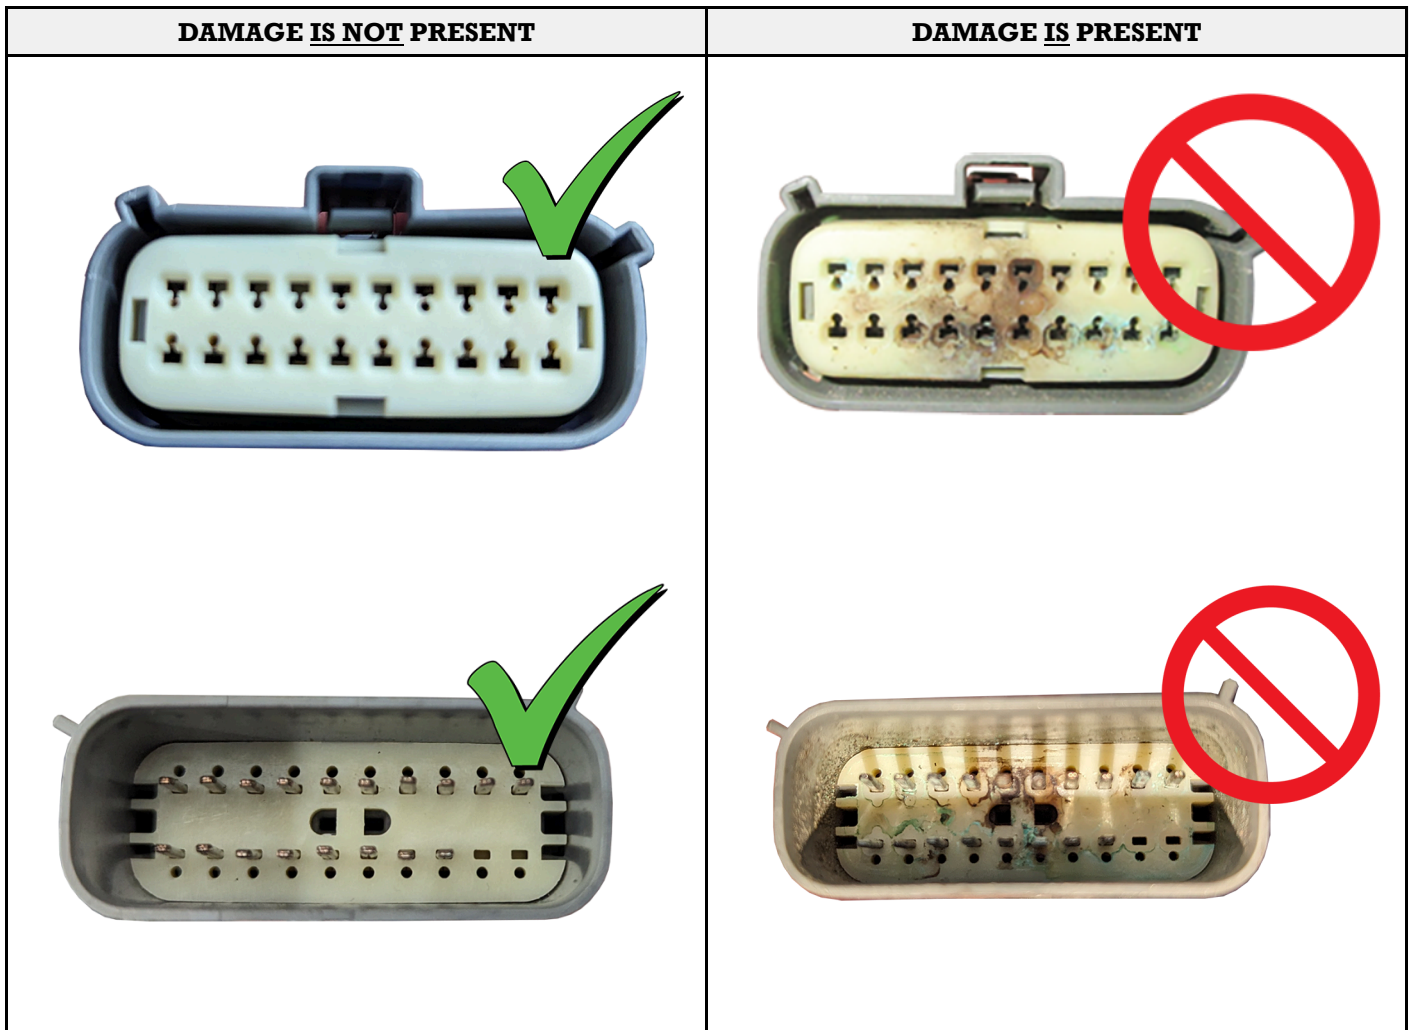
2. Inspect **BOTH** ends of the connector for damage.

Damage = Any sign of corrosion damage on the chassis harness connector (e.g. the corrosion damage shown in the right image above).

- If damage **IS** present, take pictures of the connector damage, missing cavity plugs, and proceed to I-24-01-AB US/CAN: Submit an Ask Polaris Service & Warranty Question> All Vehicle Diagnostic case. Add "I-24-01-AB corrosion present" in the concern statement.
INT'L: Contact your Country Service Department.
- If damage is **NOT** present, proceed to Cavity Plug Installation to complete I-24-01-AA.
