<b>TSB #:</b>	TSB-90012401	<b>Release Date:</b>	2/13/2024
<b>Main Group:</b>	90 - Labels		
<b>Subject:</b>	VECI Emission Label Retrofit		
<b>Vehicle:</b>	FM29 OCEAN	<b>Production Range:</b>	9/29/2022 - 12/13/2023
<b>Model Year(s):</b>	2023	<b>Region(s):</b>	United States & Canada
<b>Mobile Service:</b>	YES

**SERVICE ACTION:** SA-2401-US/CN **Install Corrected Emissions Label**

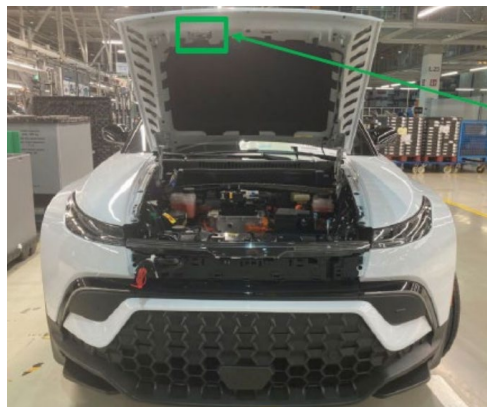
- The VECI label must be checked and replaced if necessary.
1. Open the hood. Refer to Fisker Ocean Service Manual V2.0: Body Closures > Hood > Open Hood.
  2. Locate the VECI label on the underside of the hood (front section).

- Inspect the label by checking the **Group**. If the second letter is "E", it is the incorrect label and must be replaced.

**Wrong Group: PEGIV00.0LLA**

**Correct Group: PFGIV00.0LLA**

- Clean the surface of the old label with a non-abrasive cleaning agent (i.e., Windex). Make sure the surface is clean and dry.
- Carefully apply the new label directly over the old label. Try to align the new label so it covers the old label completely.
- Close and secure the hood.  
Refer to Fisker Ocean Service Manual V2.0: Body Closures > Hood > Close Hood.
